# Chemical Process Safety

Learning from  
Case Histories

Third Edition

ROY E. SANDERS

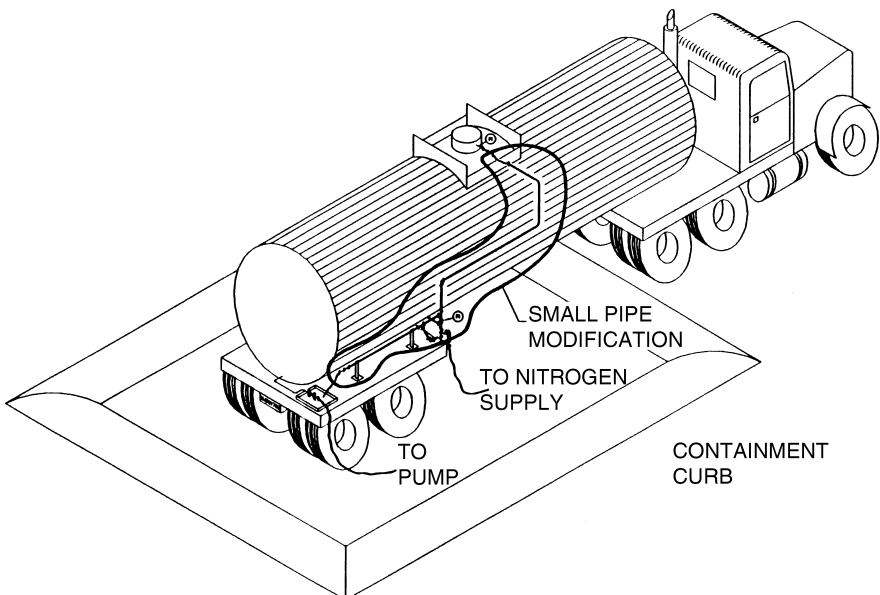
FIGURE 2-3 Tractor and tank truck ready to unload. Courtesy of Manuel David.

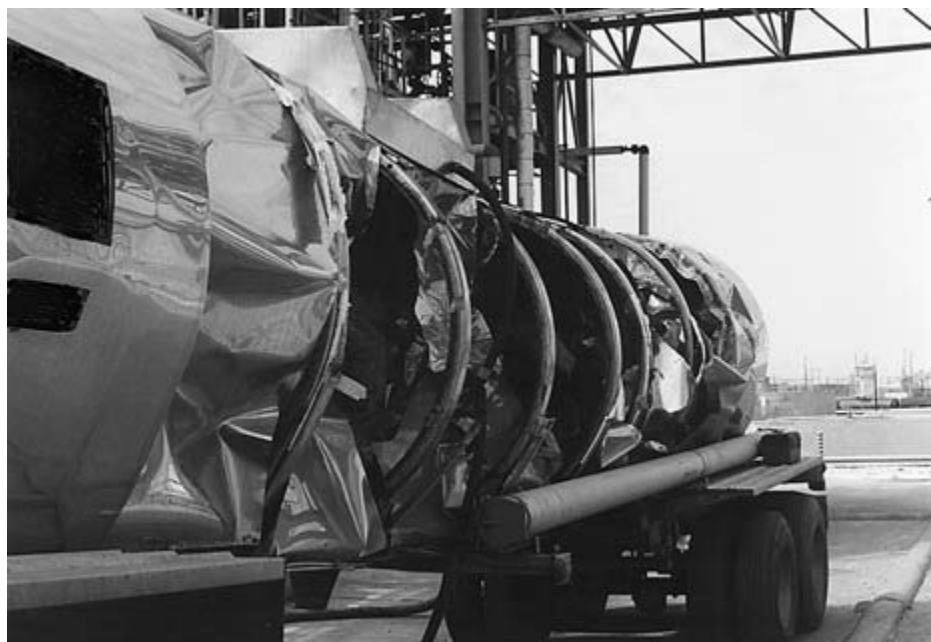
FIGURE 2-5 Close-up of tank failure and exposed ribs.

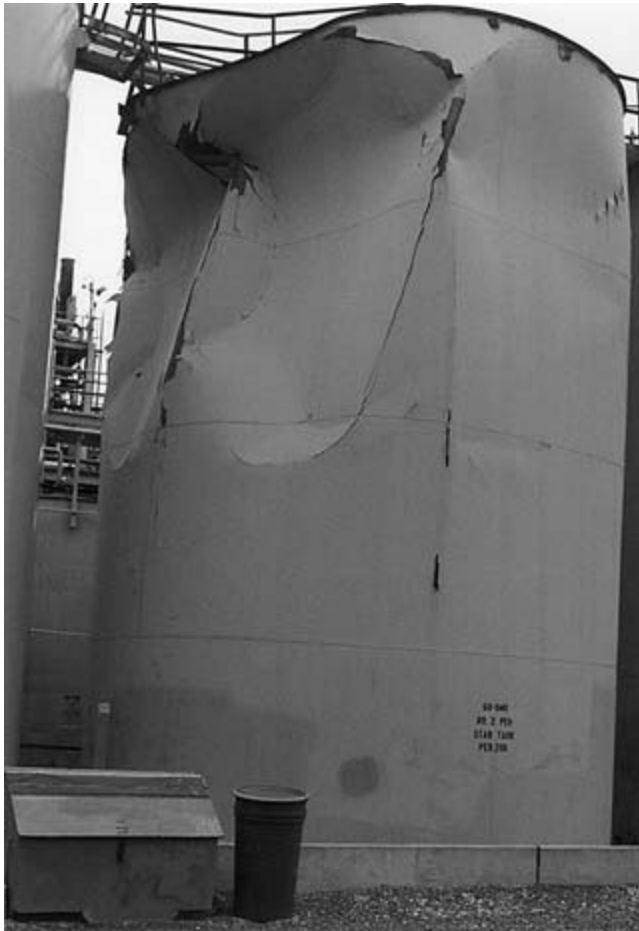
FIGURE 2-13 A 12-ft.-diameter tank ruined after vent system is improved.

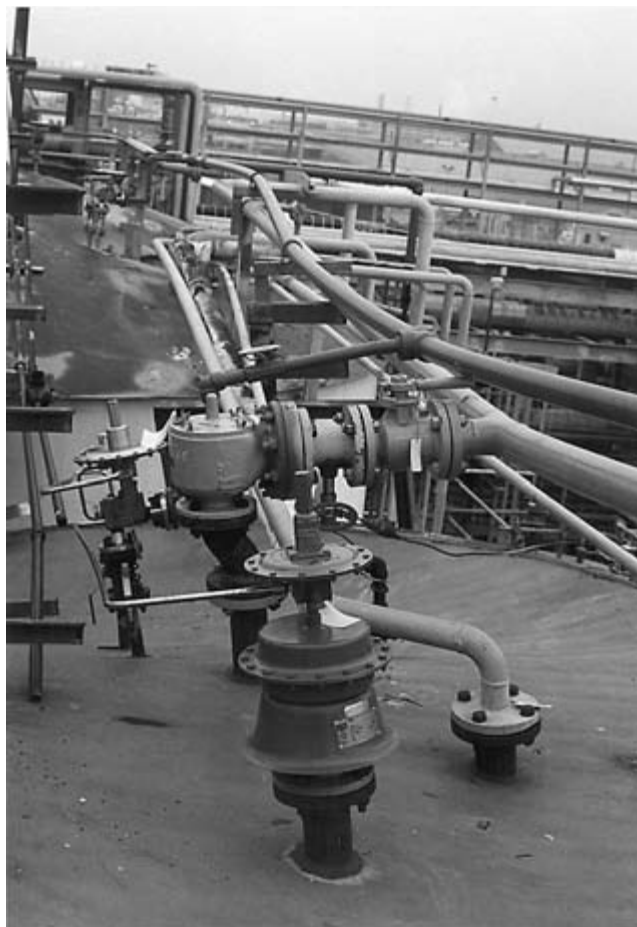
FIGURE 2-15 New but visually confusing piping system—after the incident.

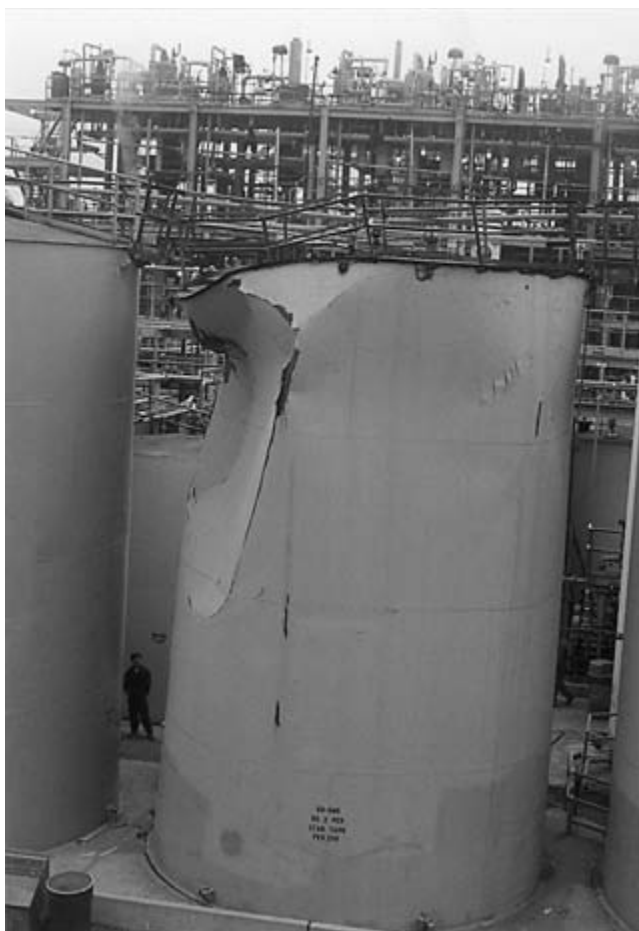
FIGURE 2-16 Crushed tank in the tank farm.

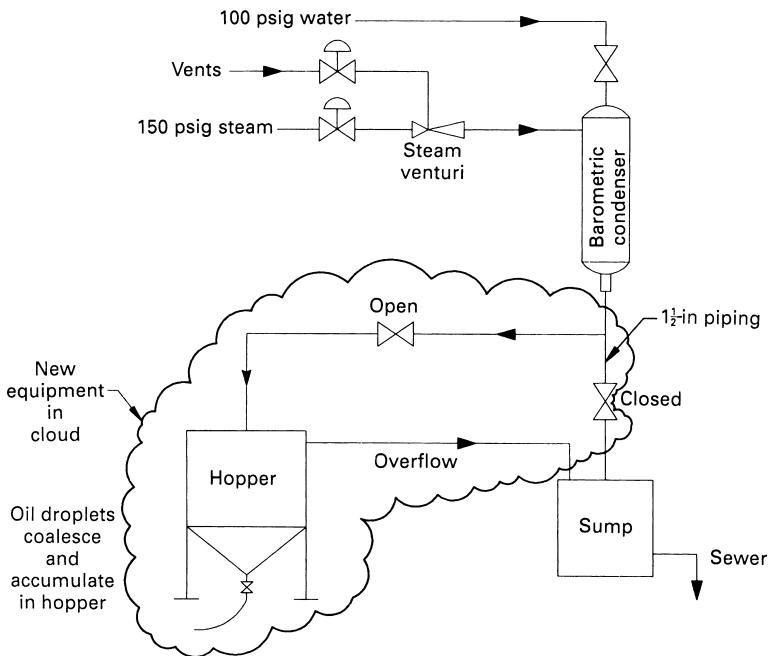
FIGURE 2–17 Modifications on water piping to reduce pollution potentials.  
Courtesy of Jack M. Jarnagin.

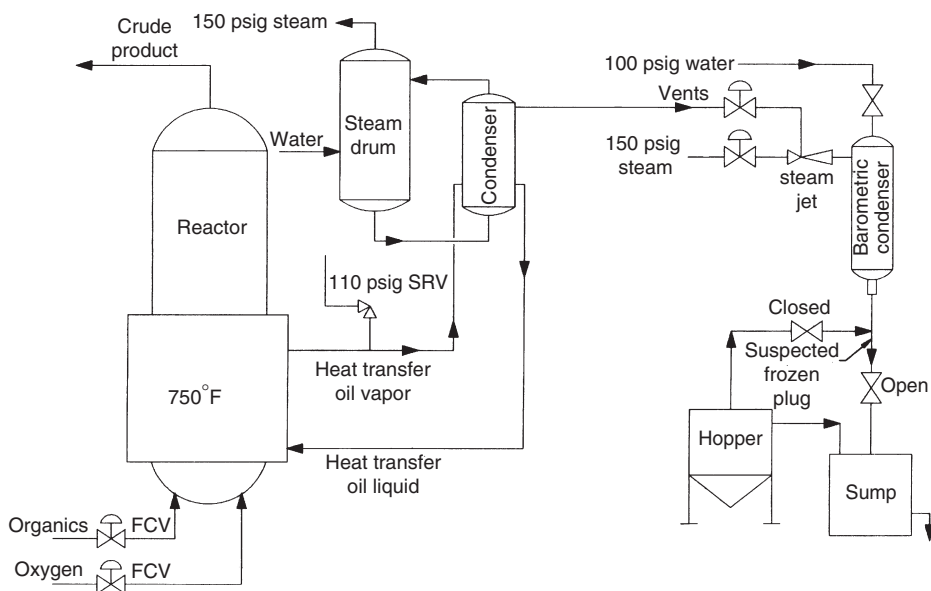
FIGURE 2-18 Solvents reactor system just before the explosion.  
Courtesy of Jack M. Jarnagin.

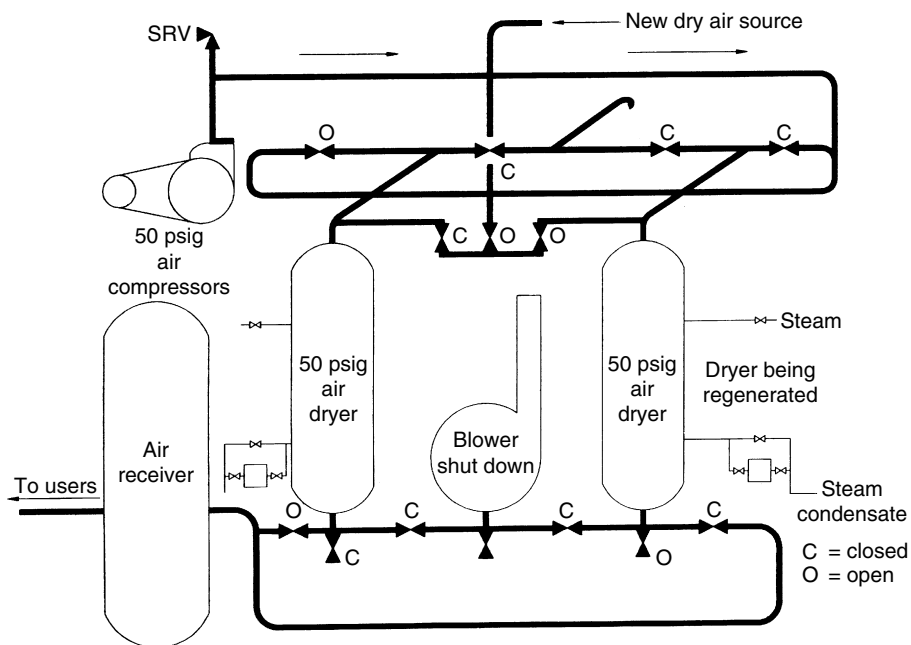
FIGURE 2-20 Modified dryer regeneration sequence at time of explosion.  
Courtesy of J. M. Jarnagin.

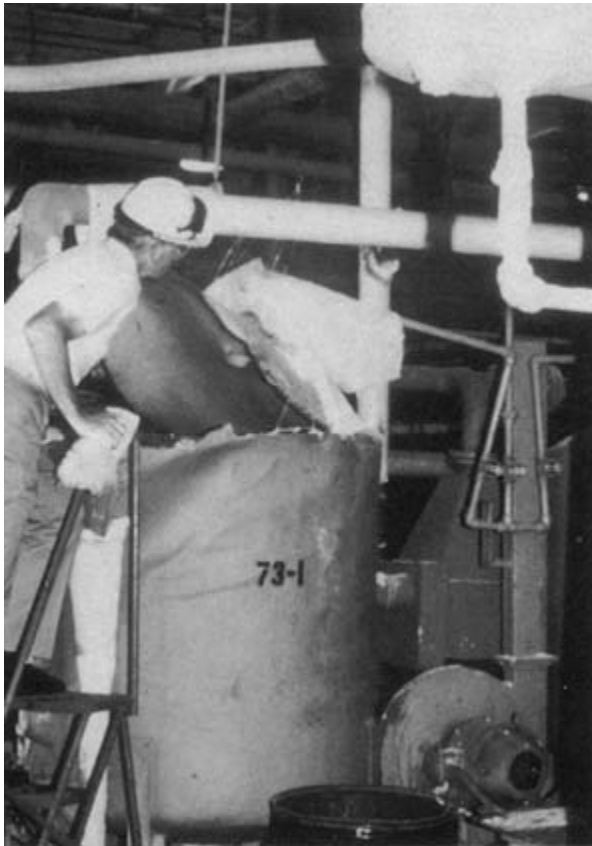
FIGURE 2-21 Employee examines the air dryer failure.

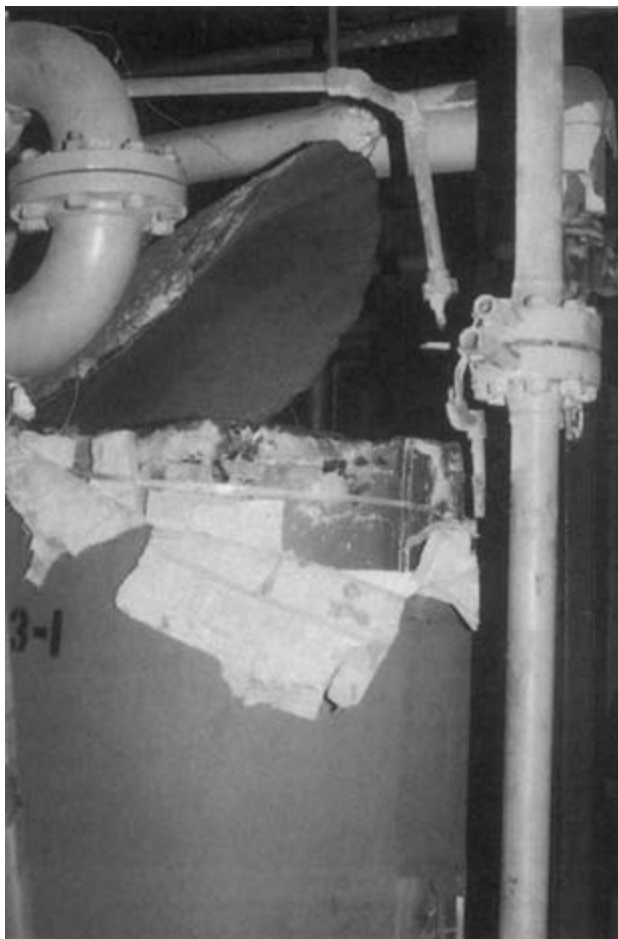
FIGURE 2-22 Close-up of the failed air dryer.

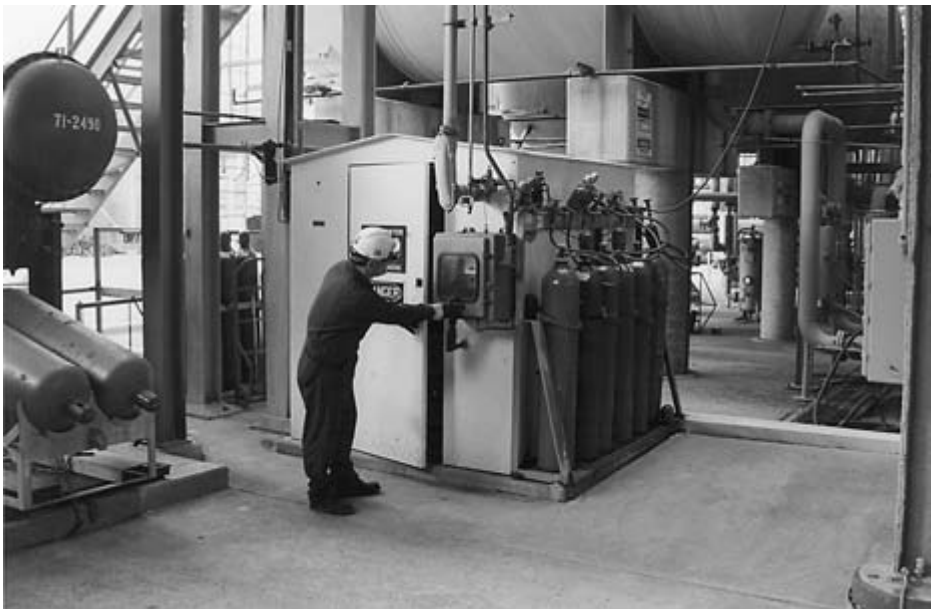
FIGURE 2-23 Typical pressurized and purged analyzer buildings found in chemical plants handling flammables.

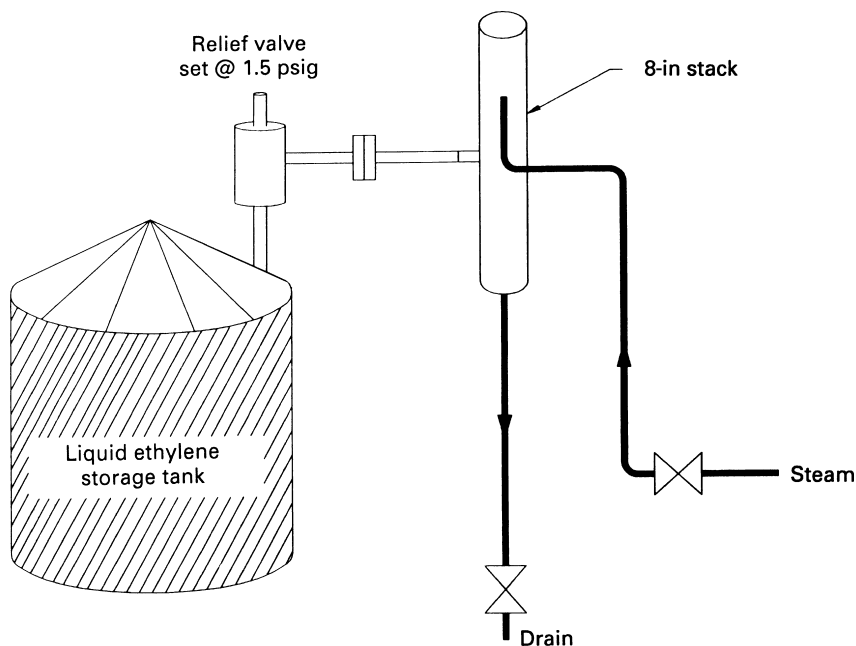
FIGURE 2–25 Well-intended vent modifications. Courtesy of T. A. Kletz.

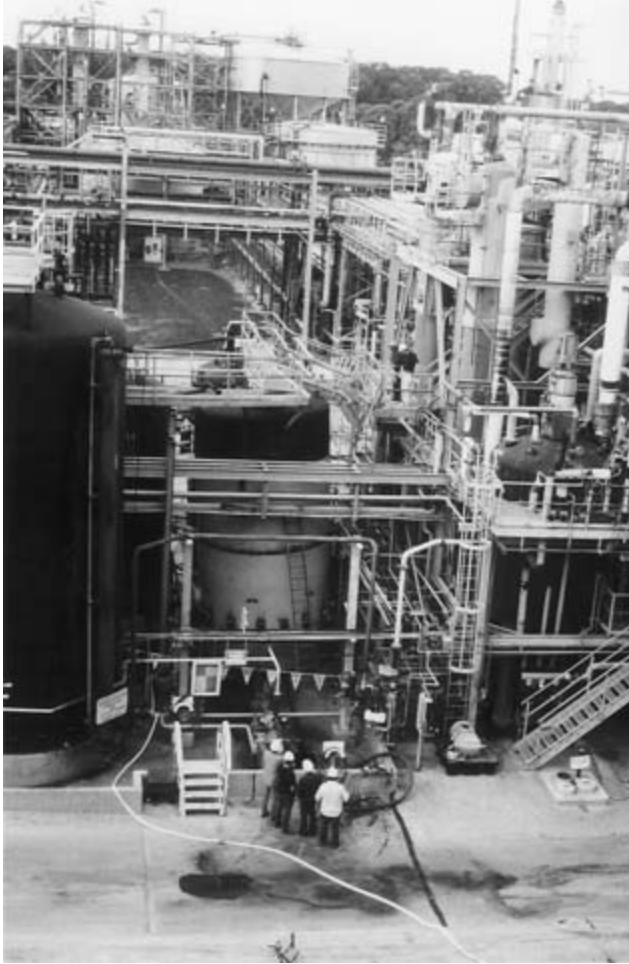
FIGURE 3-1 An API 620 tank is damaged during a hydrotest.

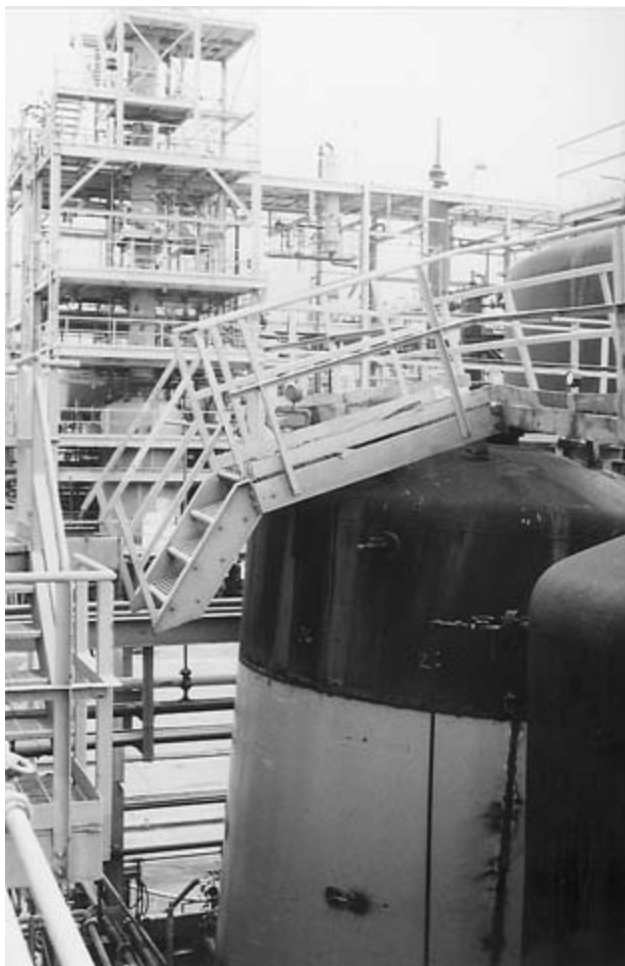
FIGURE 3-2 A closer look at the slightly leaning tank and the walkway that was torn off during the hydrotest.

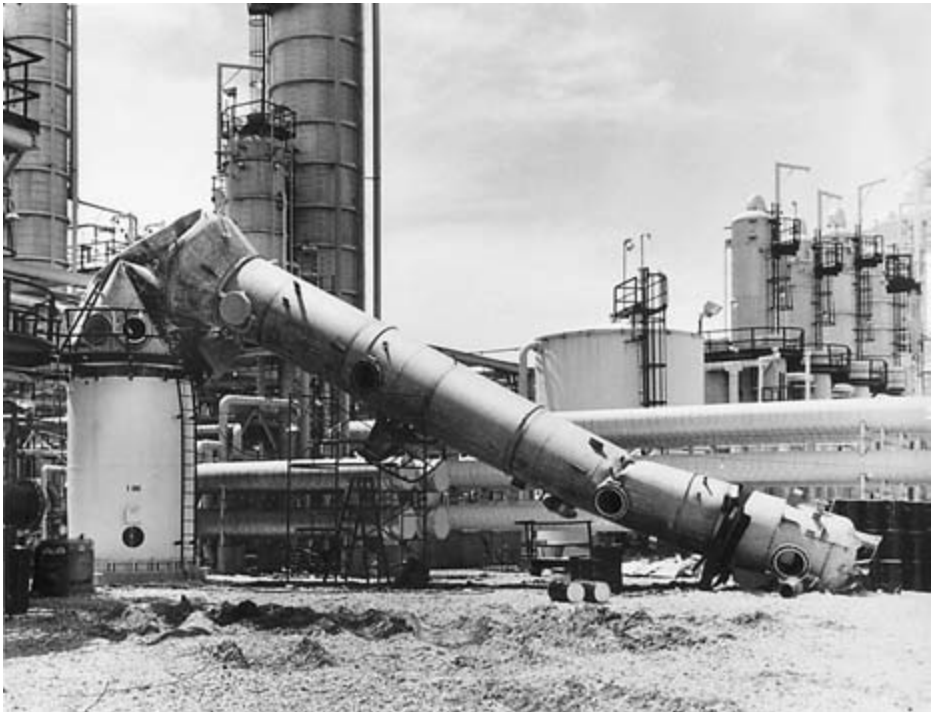
FIGURE 3-5 A stripper column collapses. Courtesy of Guido DeJesus.

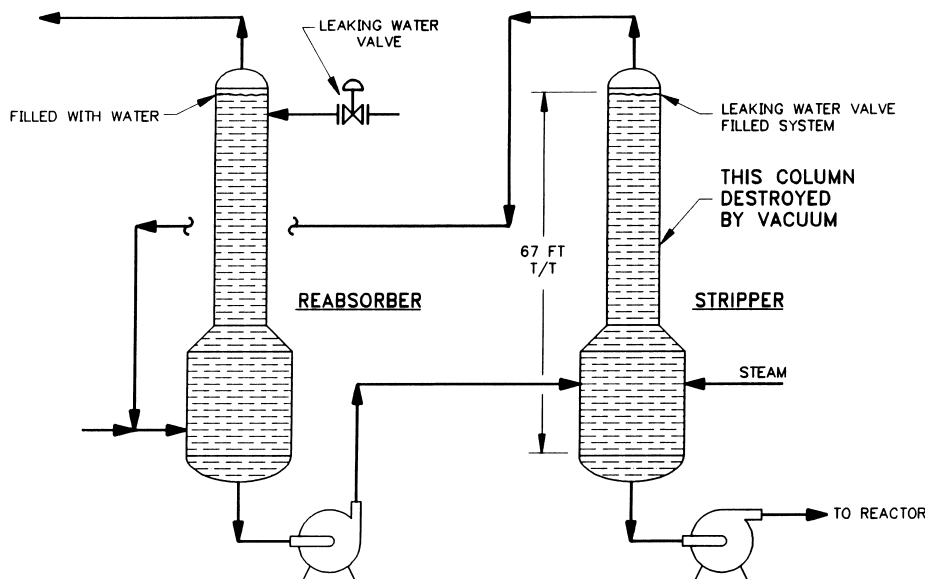
FIGURE 3-6 The design of the reabsorber/stripper system. Courtesy of Guido DeJesus and Warren Schlindler.

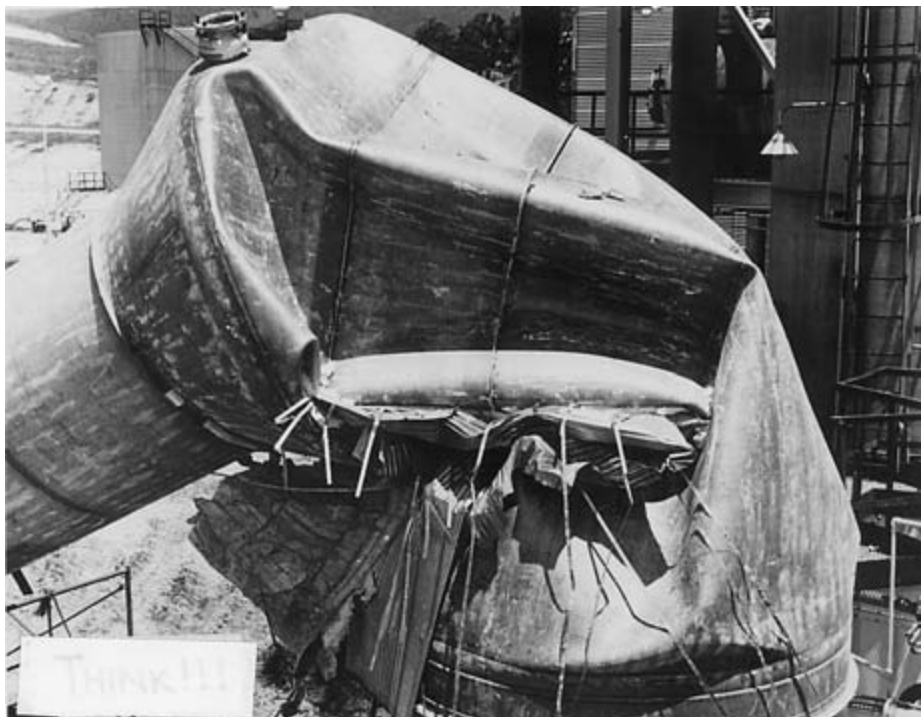
FIGURE 3-7 A close-up of a collapsed stripper column.  
Courtesy of Guido DeJesus.

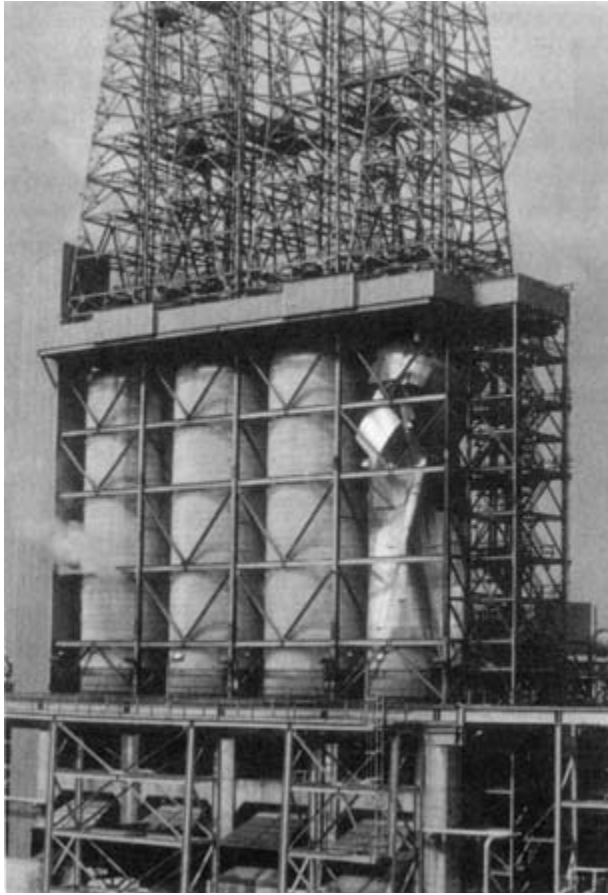
FIGURE 3–9 Collapsed coker drum in a refinery. Courtesy of S. O. Kapenieks.

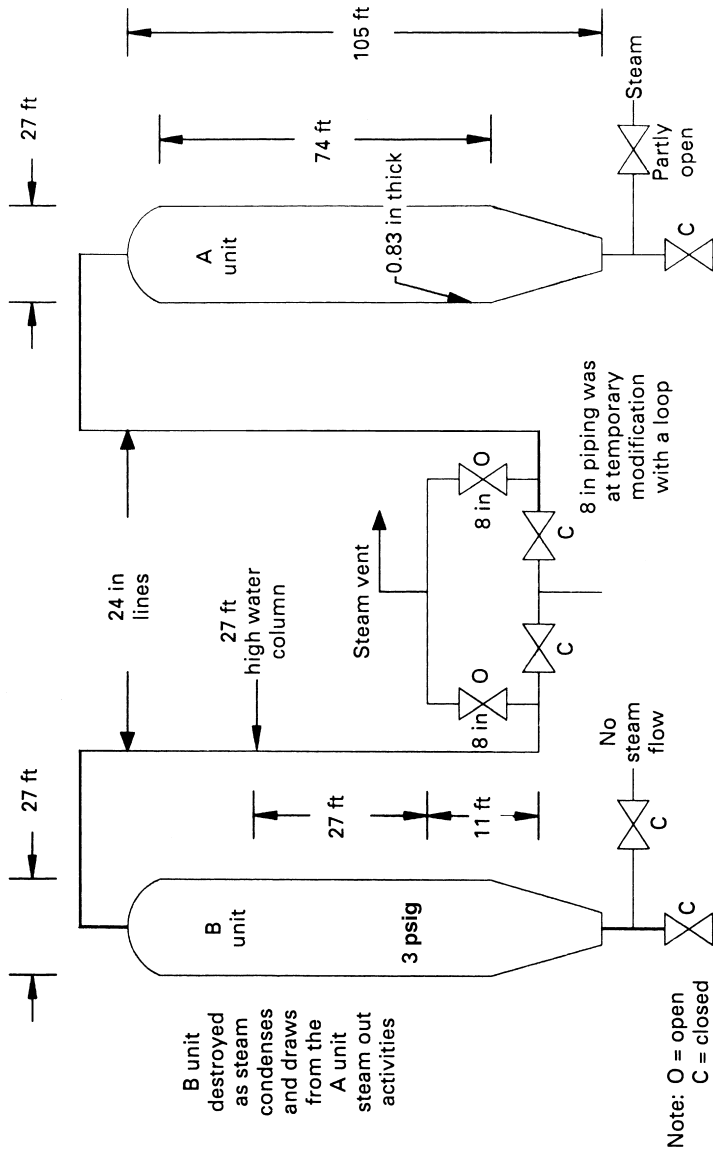
FIGURE 3-10 Conditions at the time of the failure of the coker drum.

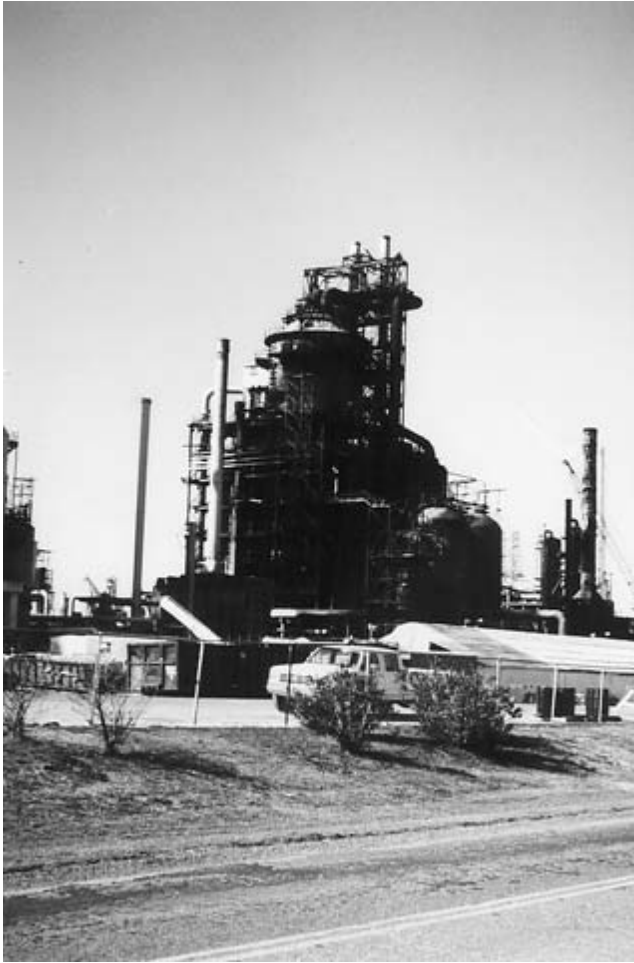
FIGURE 3-12 After the explosion, a charred multi-storied catalytic cracking unit.

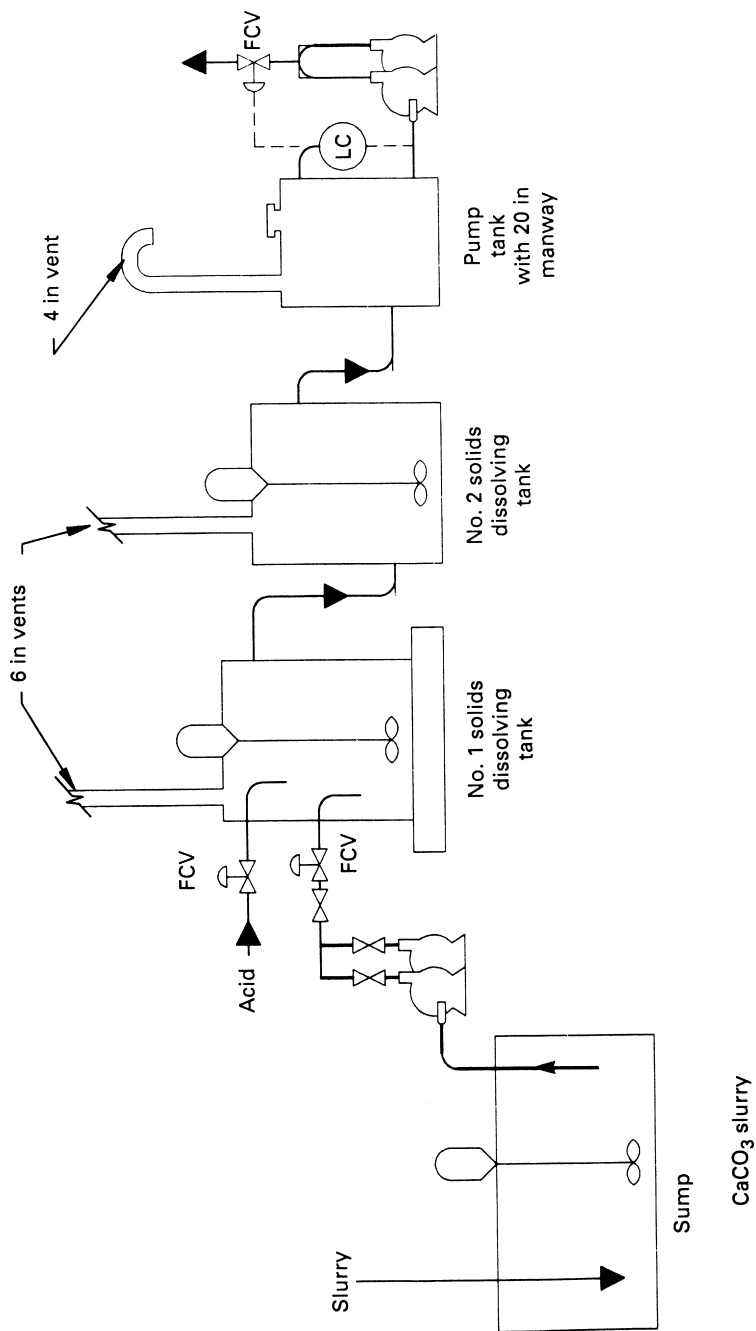
FIGURE 4-3 Slurry-dissolving system. Courtesy of J. M. Jarnagin.

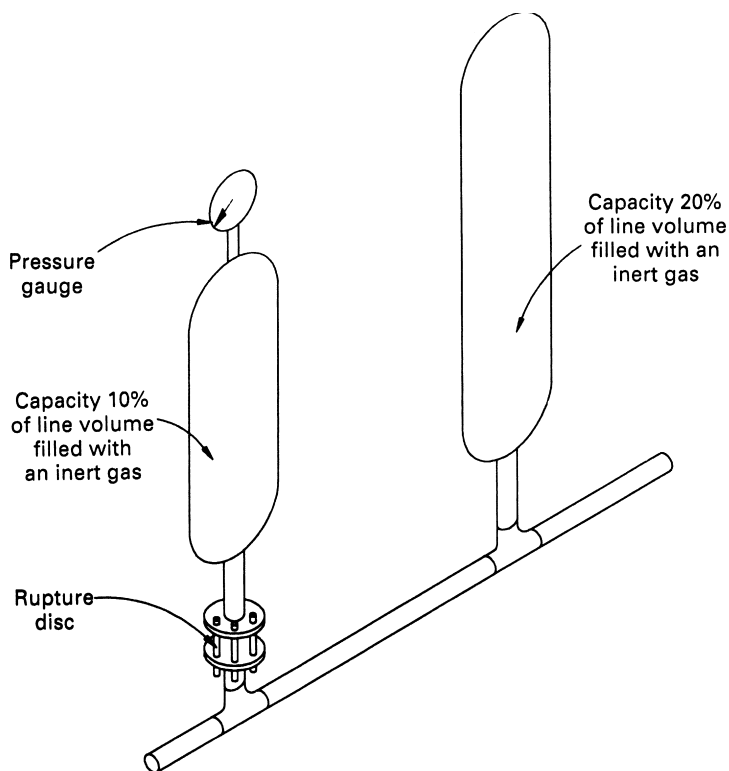
FIGURE 4-4 Expansion chambers for liquid chlorine pipeline protection. Courtesy of the Chlorine Institute, Inc.

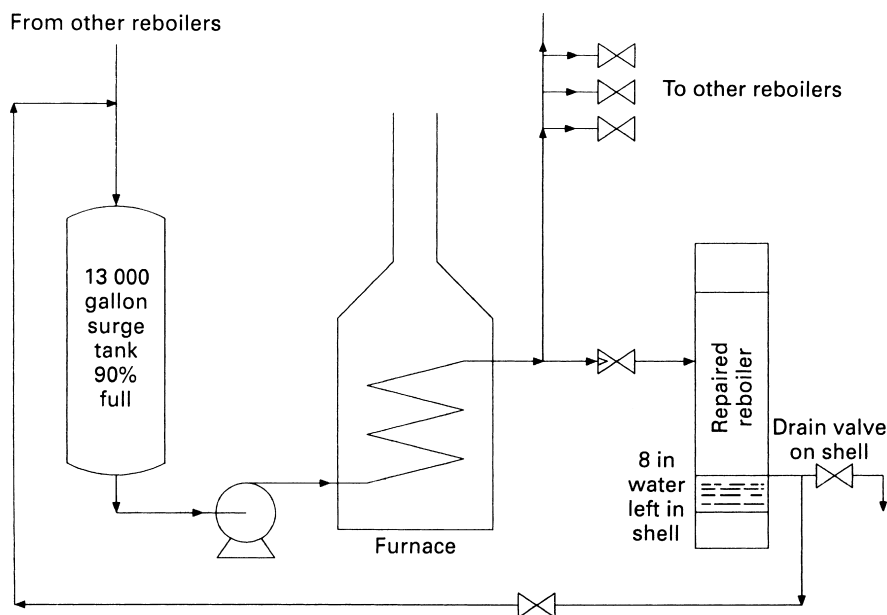
FIGURE 5–1 Residual, undetected water from a hydrotest explosively vaporizes and ruptures a surge tank. Courtesy of Trevor A. Kletz.

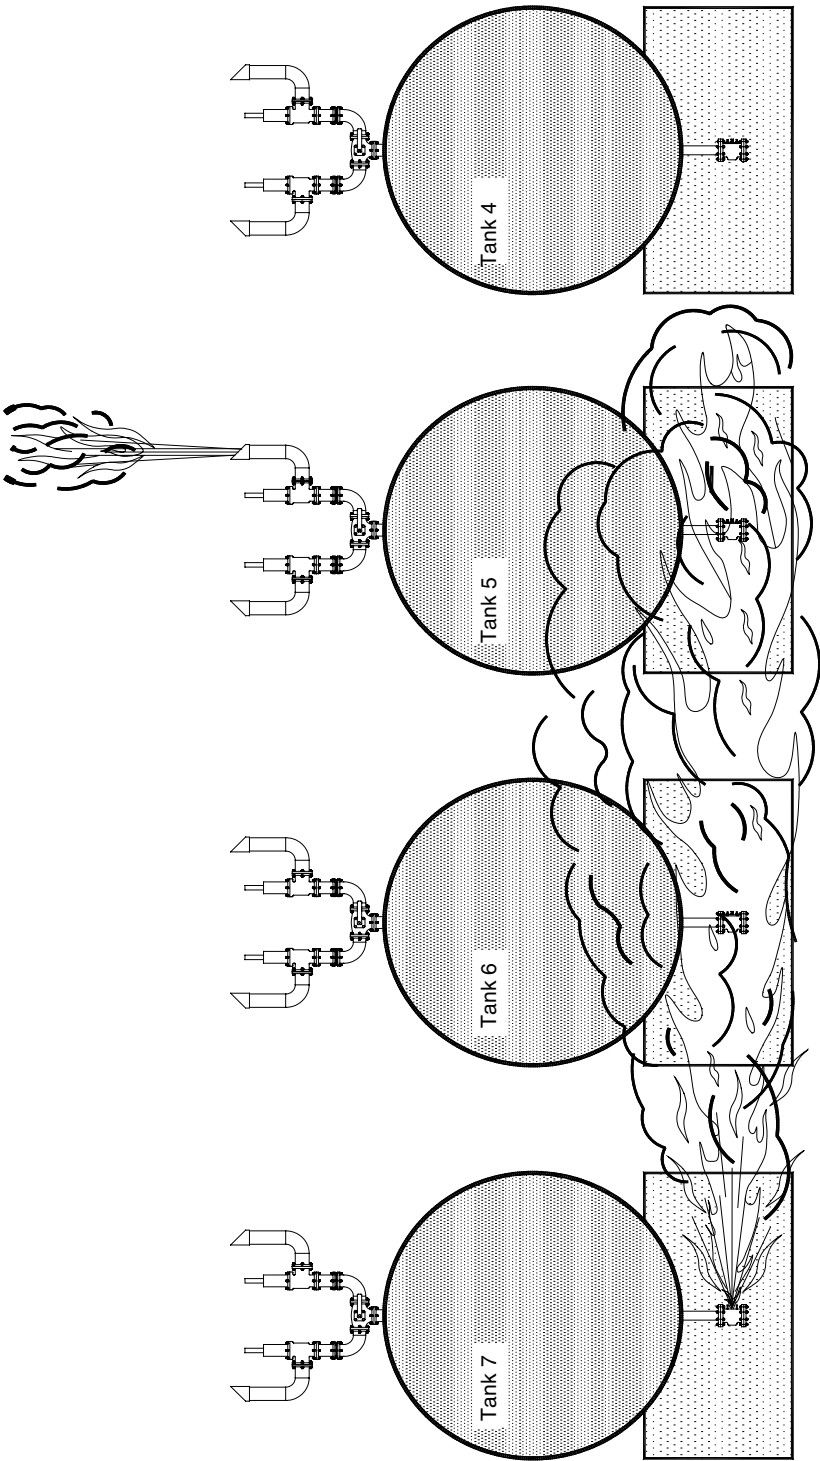
FIGURE 5-9 Flames Below the Vinyl Chloride Tanks—An Artist's Perception. Courtesy of Manuel David.

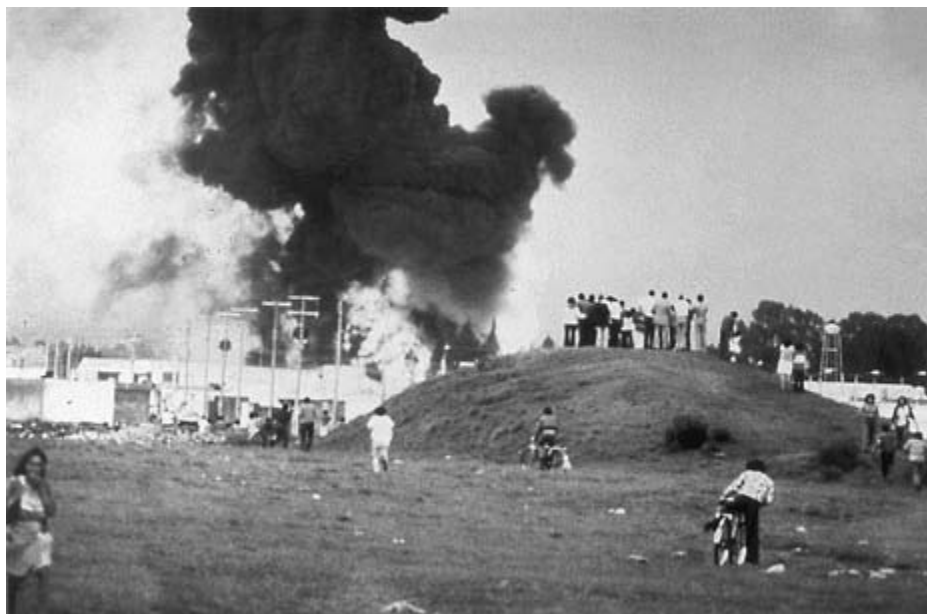
FIGURE 5-10 BLEVE of a vinyl chloride storage tank. Courtesy of the Institution of Chemical Engineers.

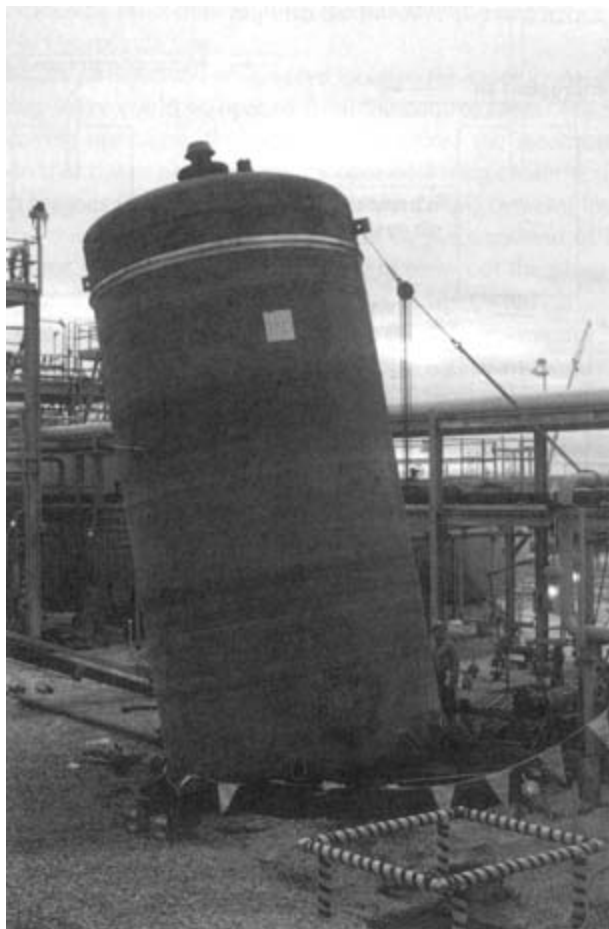
FIGURE 5-12 A large acid tank fails due to blocked vent and a blocked overflow line.

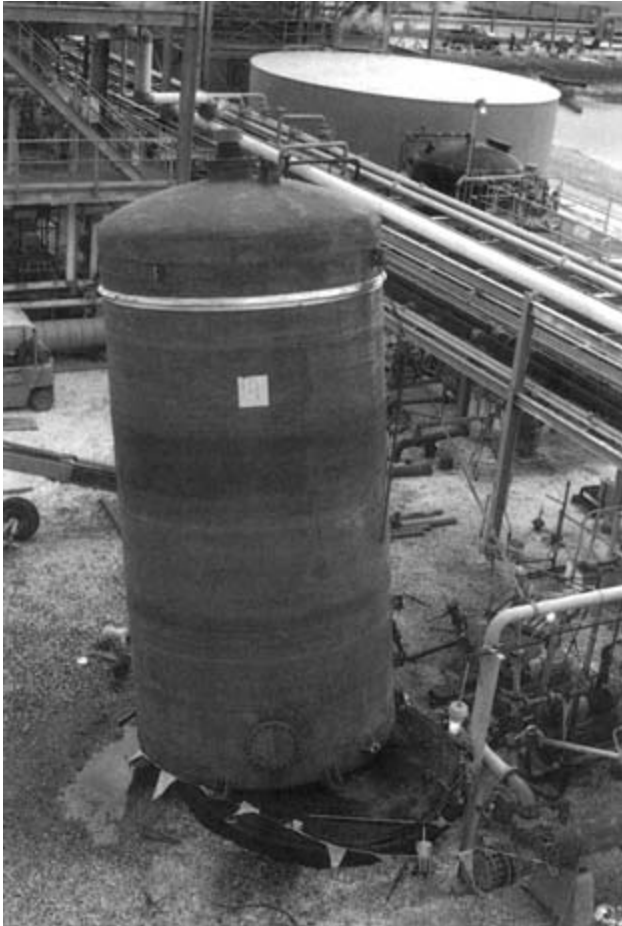
FIGURE 5-13 An aerial view of the tank failure.

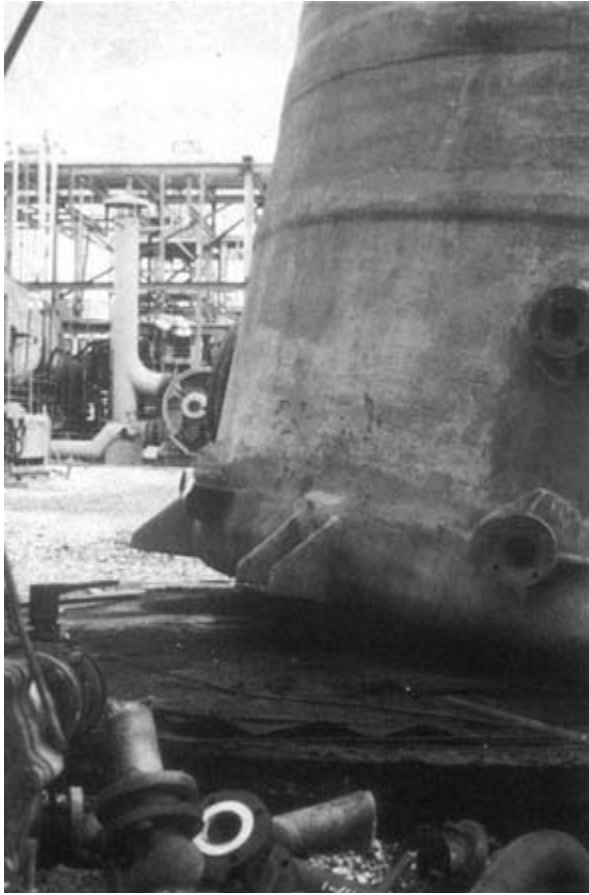
FIGURE 5-14 A close-up of the failed tank base.

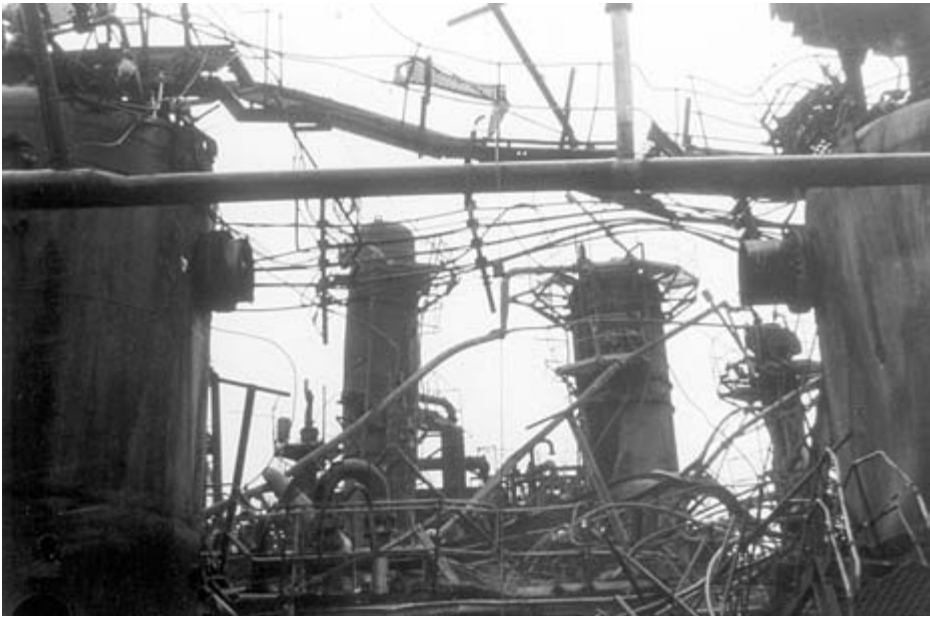
FIGURE 5-16 A Destroyed Section of the Flixborough Reactor System.  
Photo courtesy of Trevor A. Kletz.

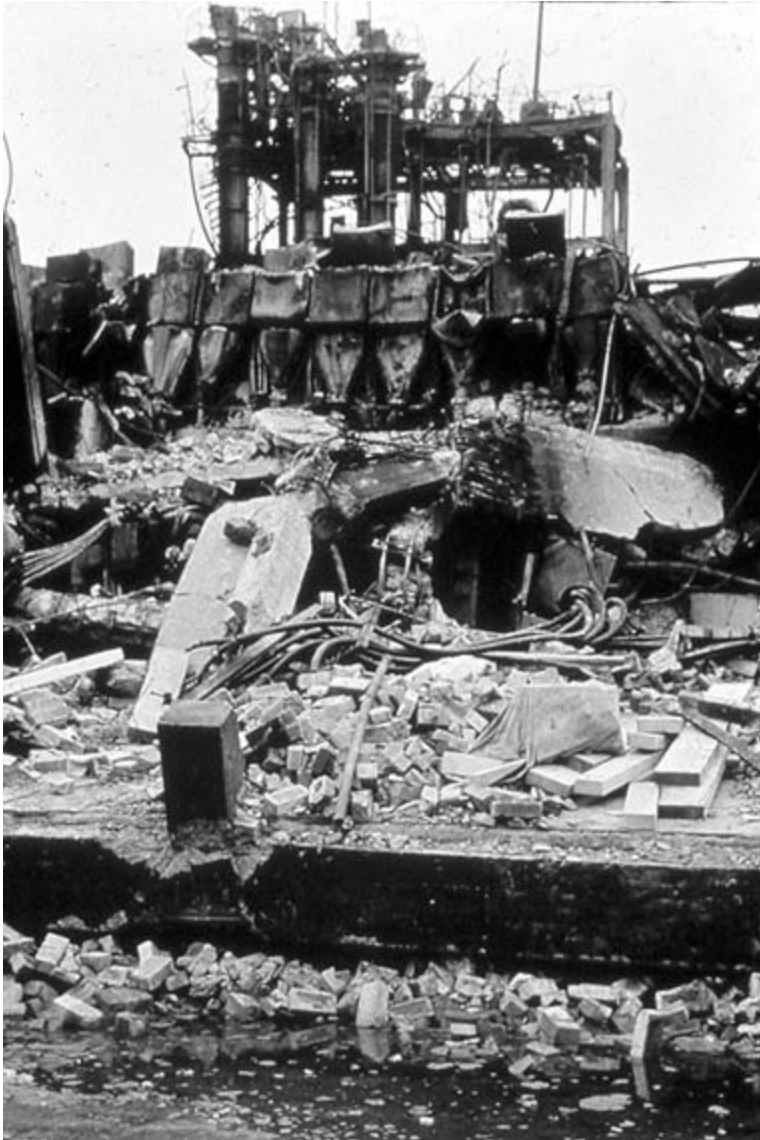
FIGURE 5-17 The rubble of the crushed control room at Flixborough. Courtesy of Trevor A. Kletz.

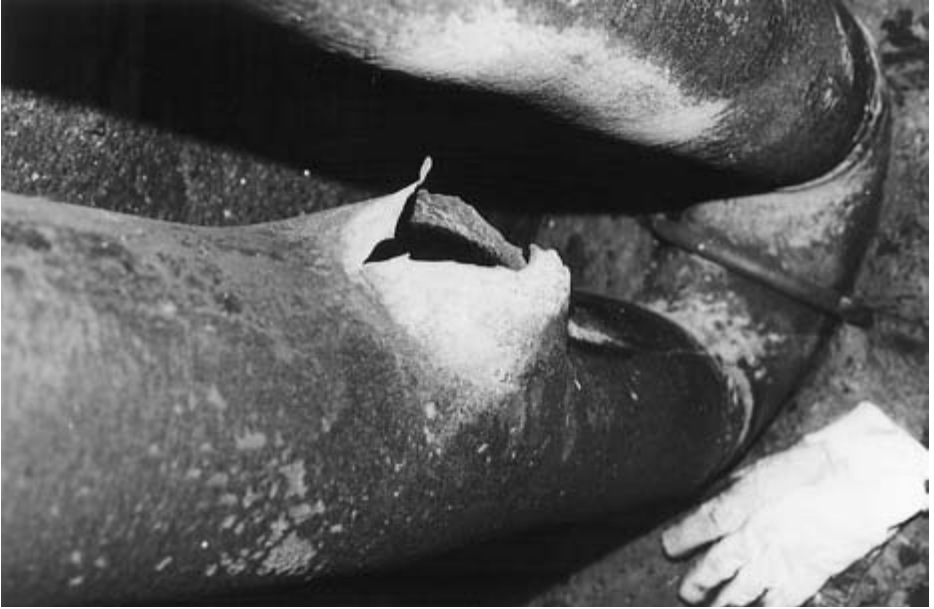
FIGURE 6-2 Tube rupture in a fired heater.

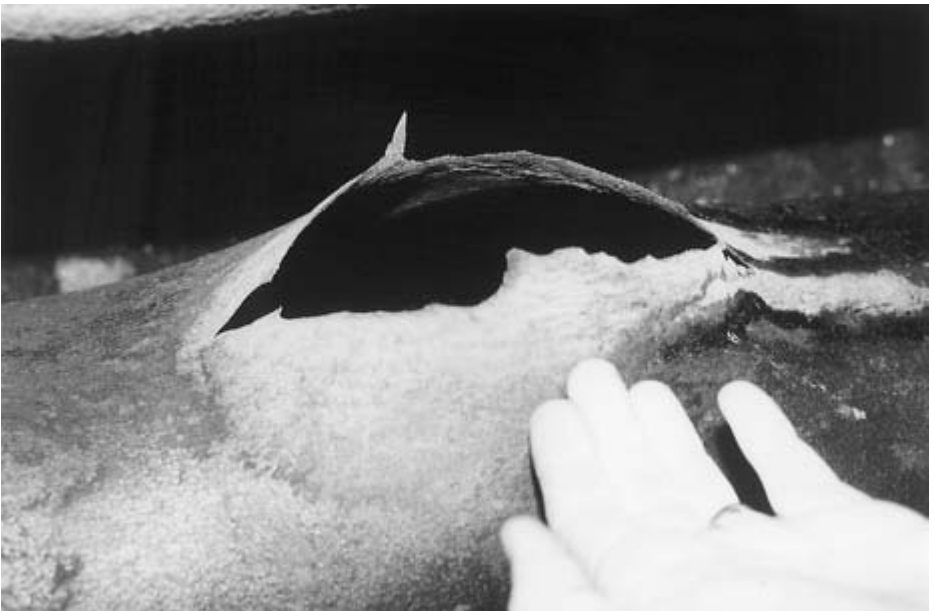
FIGURE 6-3 Close-up of the tube failure.

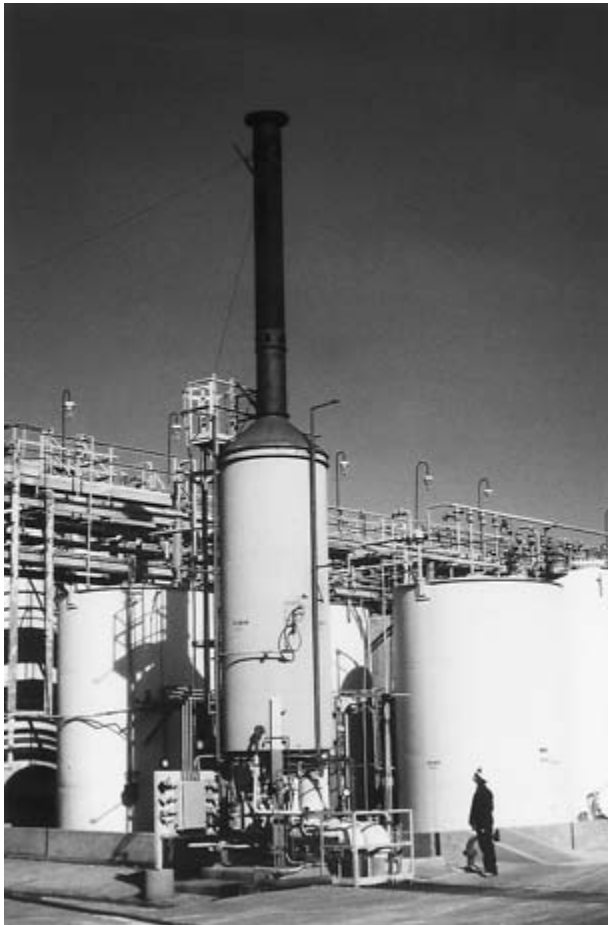
FIGURE 6-4 The rejuvenated and relocated gas-fired heater.

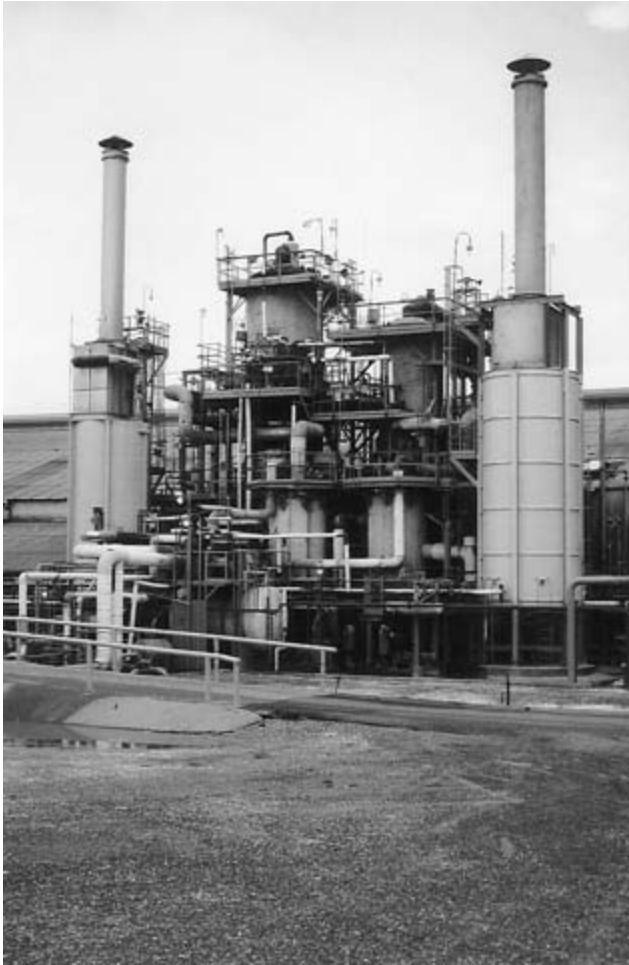
FIGURE 6-5 Well-maintained unit is troubled by a leak.

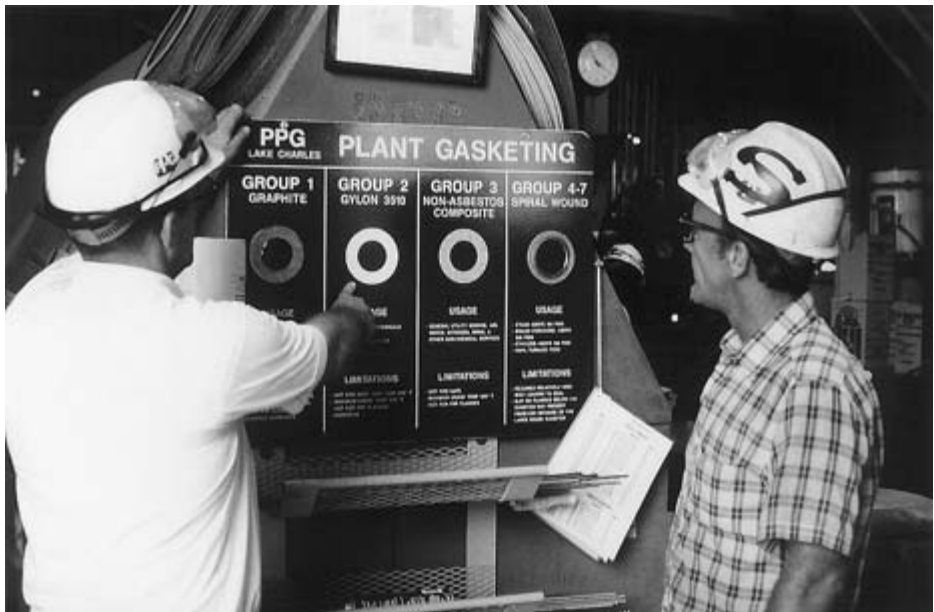
FIGURE 6-9 Choosing the proper piping gaskets with help from easy-to-understand gasket board.

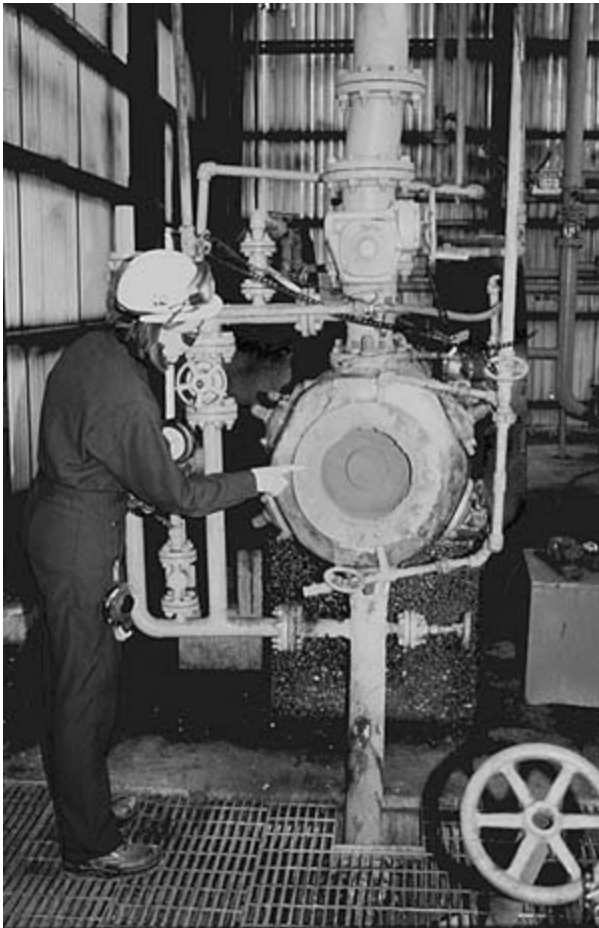
FIGURE 7-1 Reciprocating compressor with ruptured water jacket.
