# Chemical Process Safety

Learning from  
Case Histories

Third Edition

ROY E. SANDERS

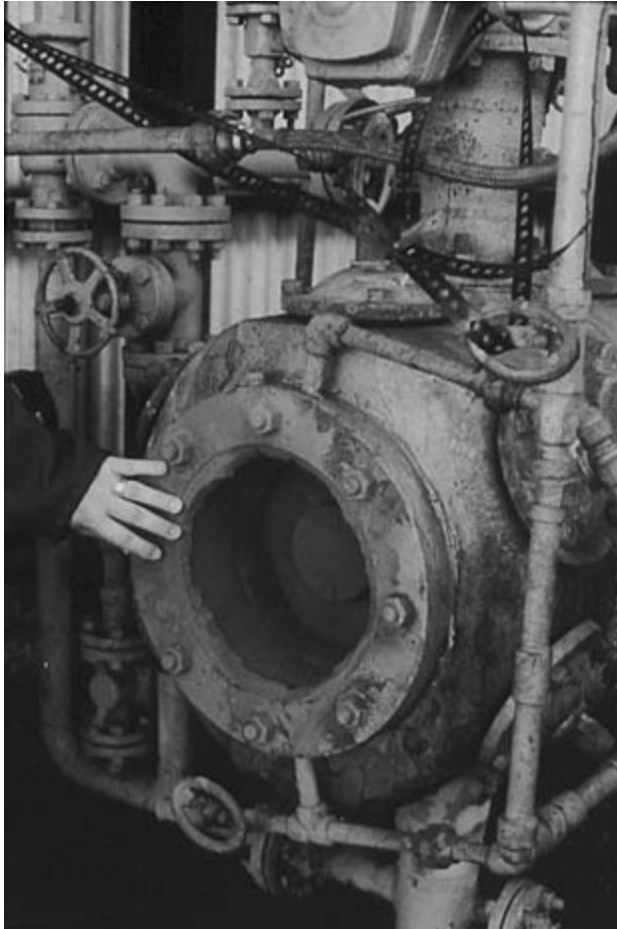
FIGURE 7-2 Close-up of ruptured water jacket on compressor.

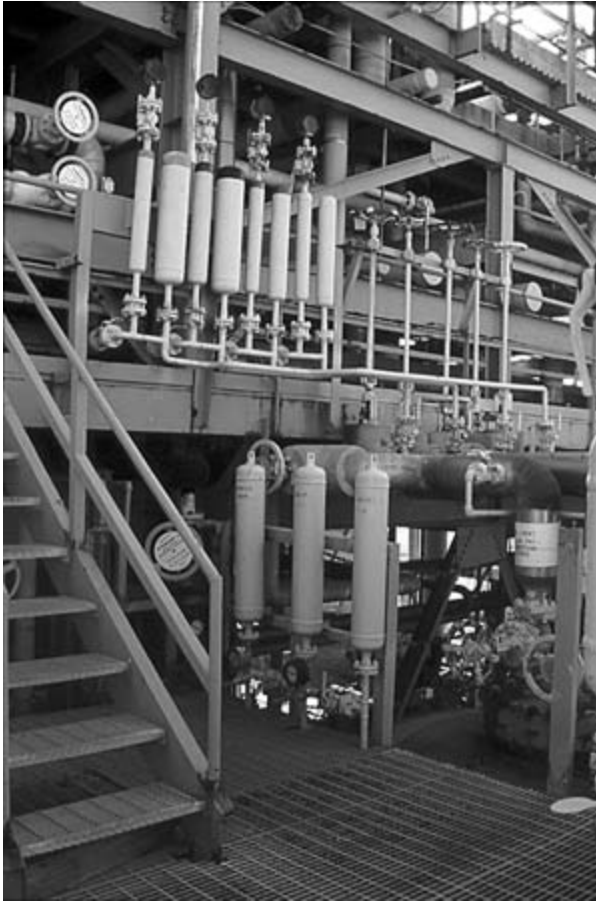
FIGURE 7-5 Expansion bottles protecting piping from overpressure.

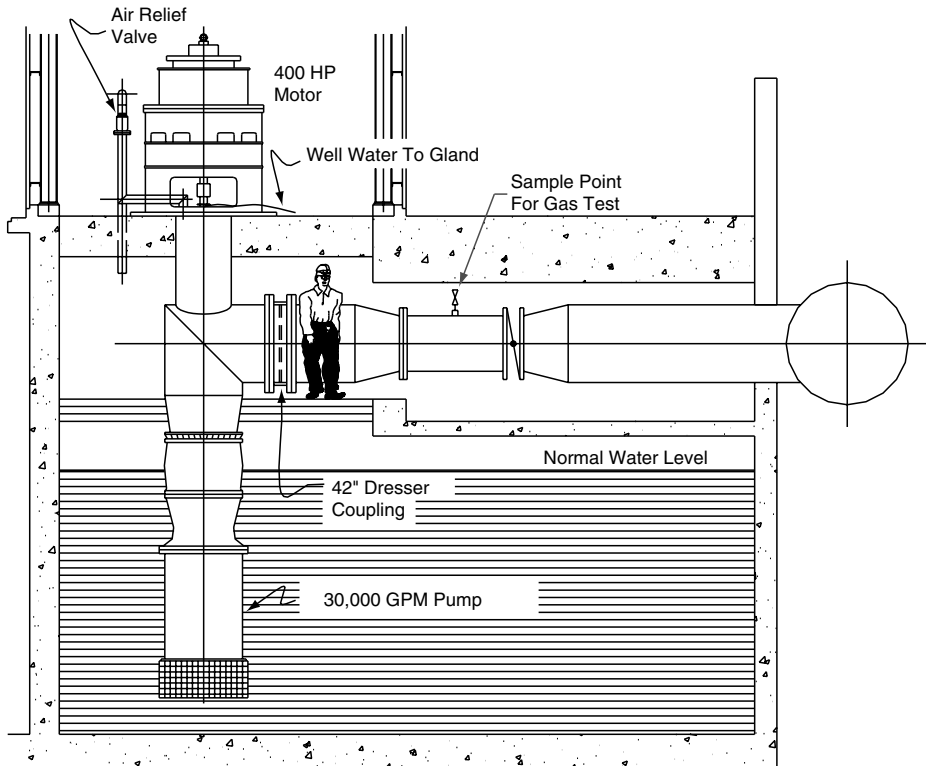
FIGURE 7-8 Sketch of the river water pump system at normal conditions. Courtesy of Manuel David.

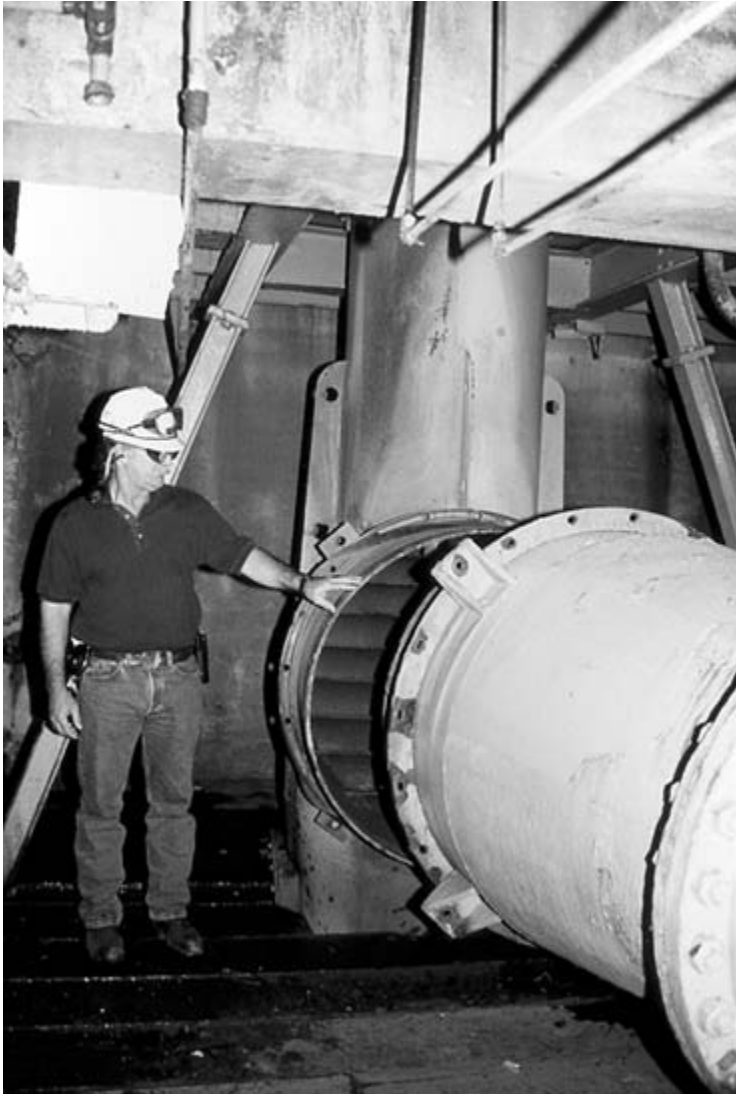
FIGURE 7-9 Photo of how the river water pump moved during the explosion.

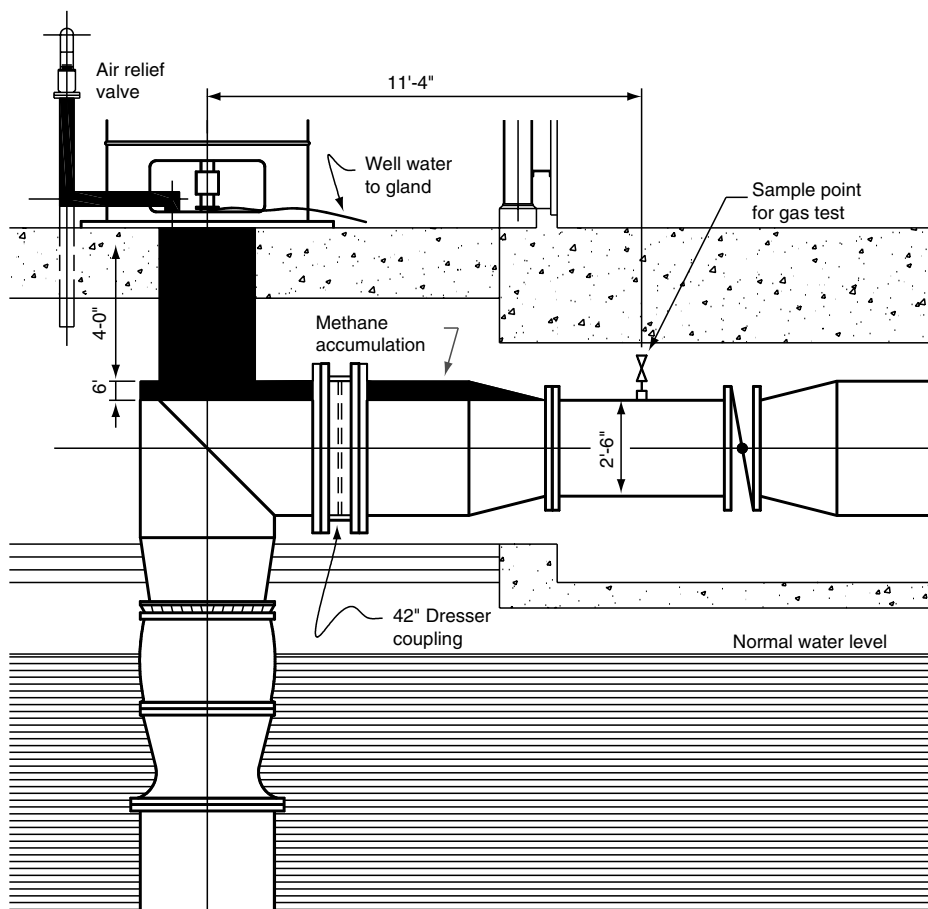
FIGURE 7-11 Sketch of how methane gas accumulated in the river water piping.

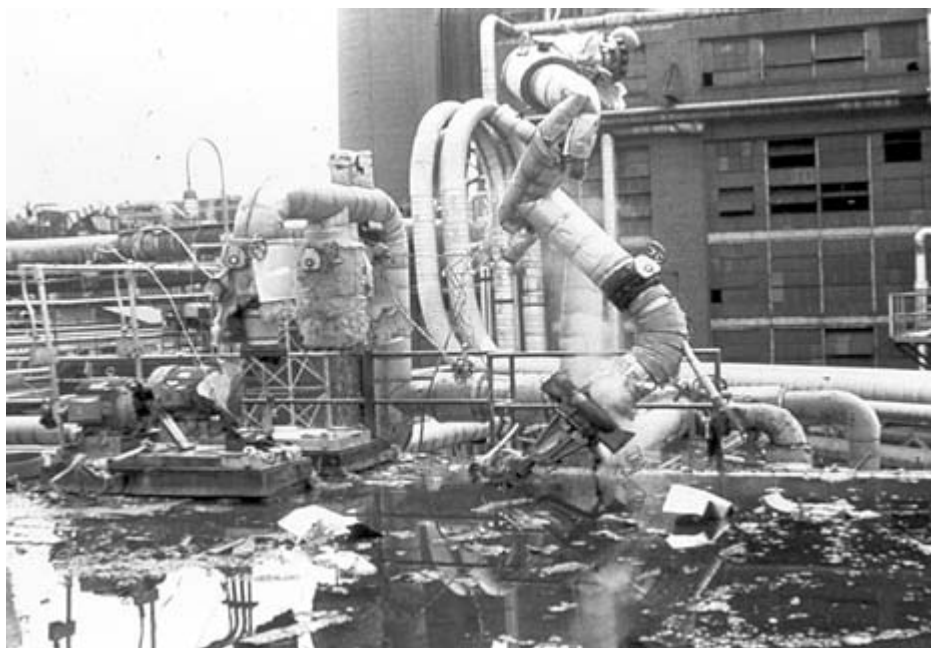
FIGURE 7-15 Heavily damaged condensate pump installation. Courtesy of Eastman Chemical Company.

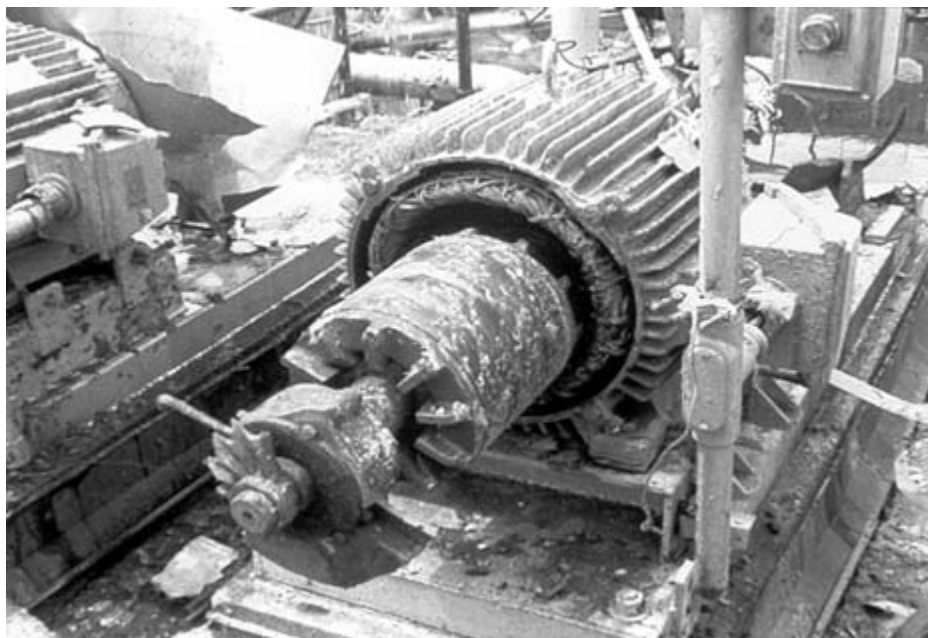
FIGURE 7-16 Explosion forces rotor out of condensate pump motor. Courtesy of Eastman Chemical Company.

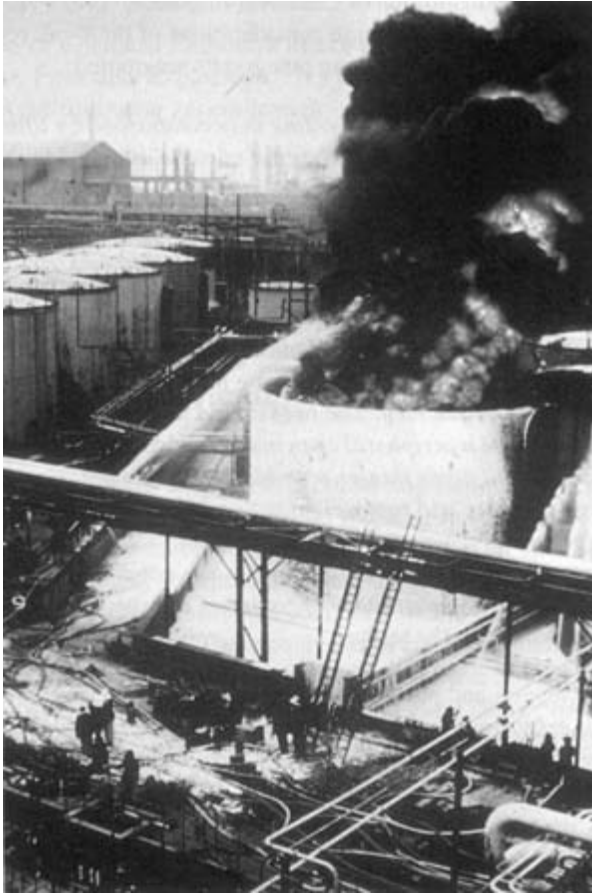
FIGURE 8-3 A fire in a giant floating roof crude oil tank. Courtesy of the Institution of Chemical Engineers. This photo can be found in Hazard Workshop Module No. 6, "Preventing Emergencies in the Process Industries, Volume 1."

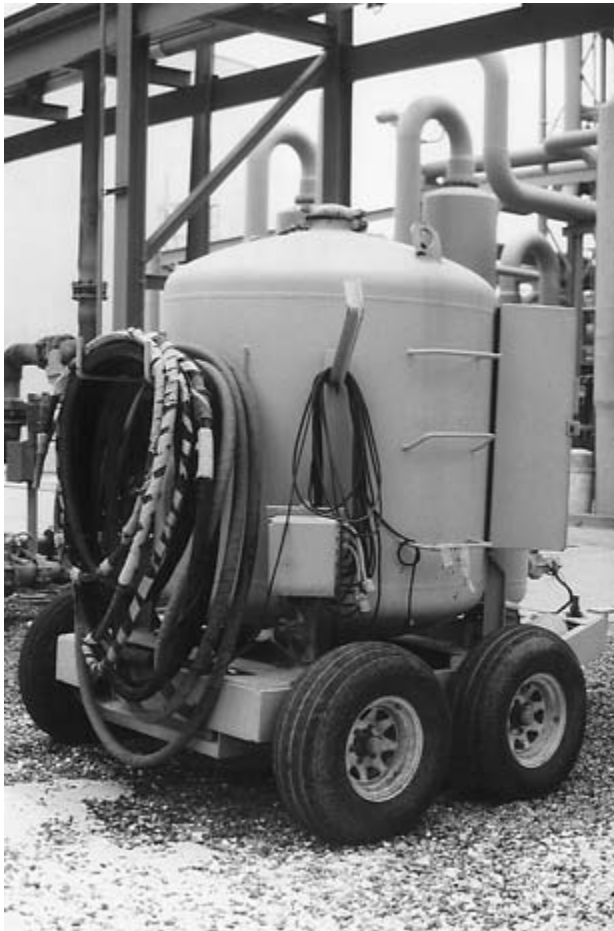
FIGURE 8-4 Repairs to a portable sandblast pot do not meet specifications and the lid flies off.

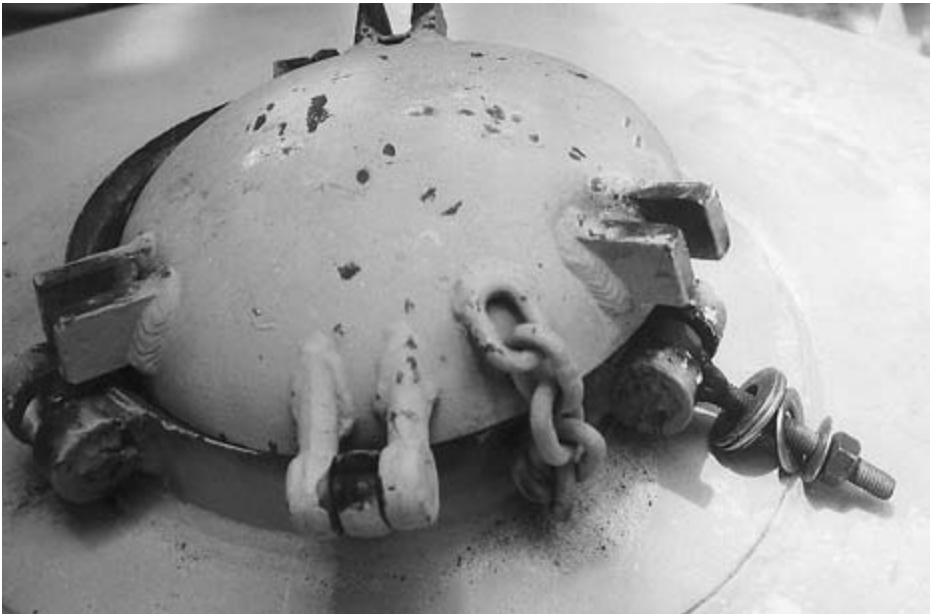
FIGURE 8-5 A close-up look at the quick closure bolts that failed on the sand pot.

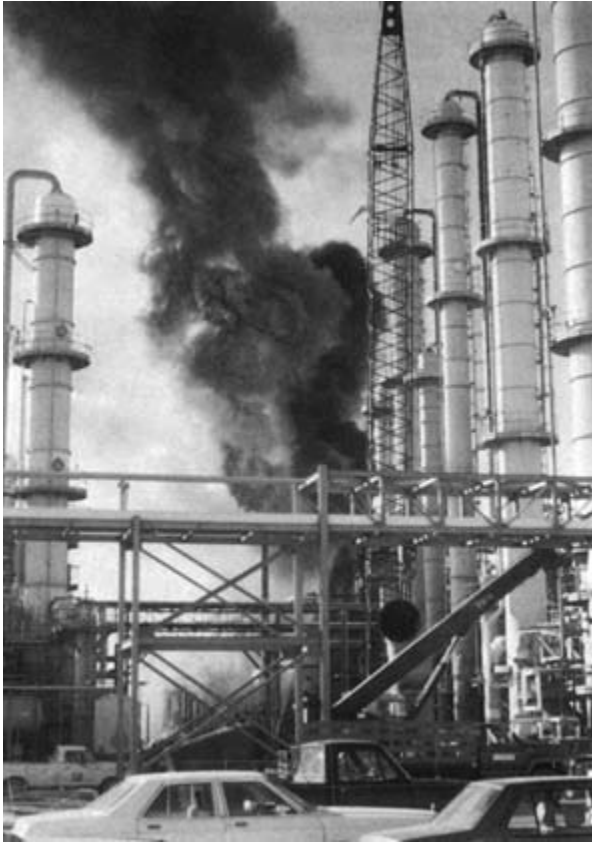
FIGURE 8-6 Fire in solvents plant as seen from the road. Courtesy of G. O. Heintzen.

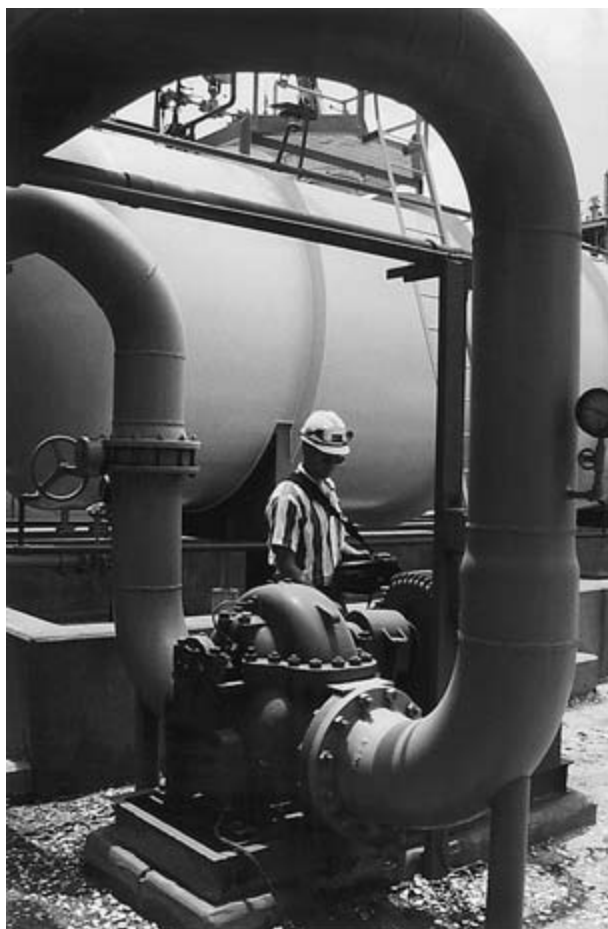
FIGURE 10-2 A vibration technician taking readings on a cooling water pump.

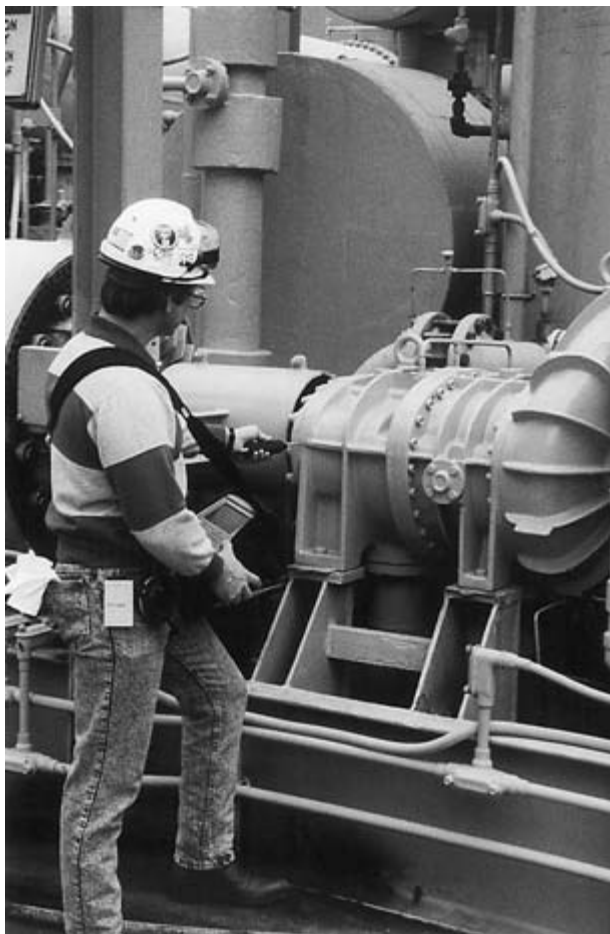
FIGURE 10-3 A vibration technician taking readings on a refrigeration compressor.

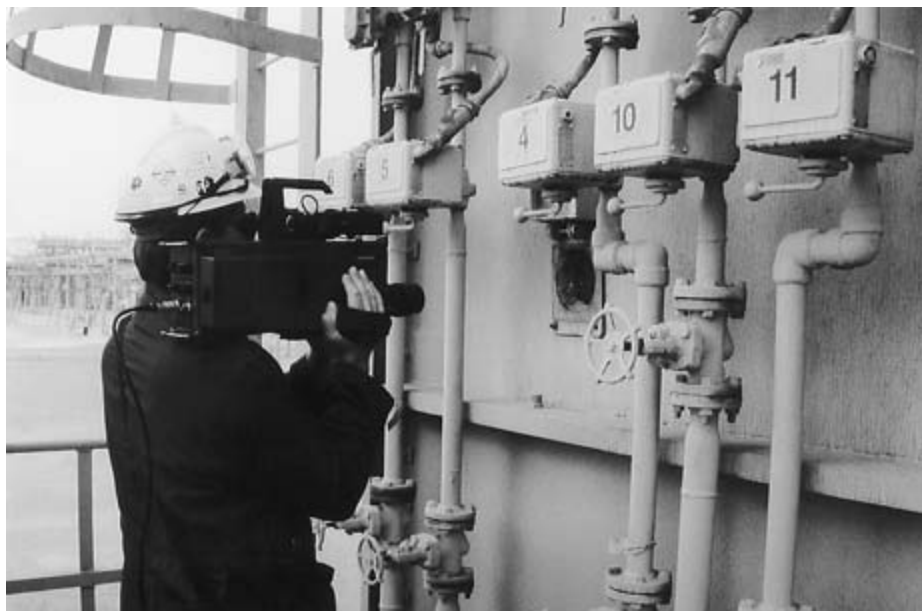
FIGURE 10-5 An inspector using an infrared camera periodically monitors furnace tube temperatures through the inspection port holes.

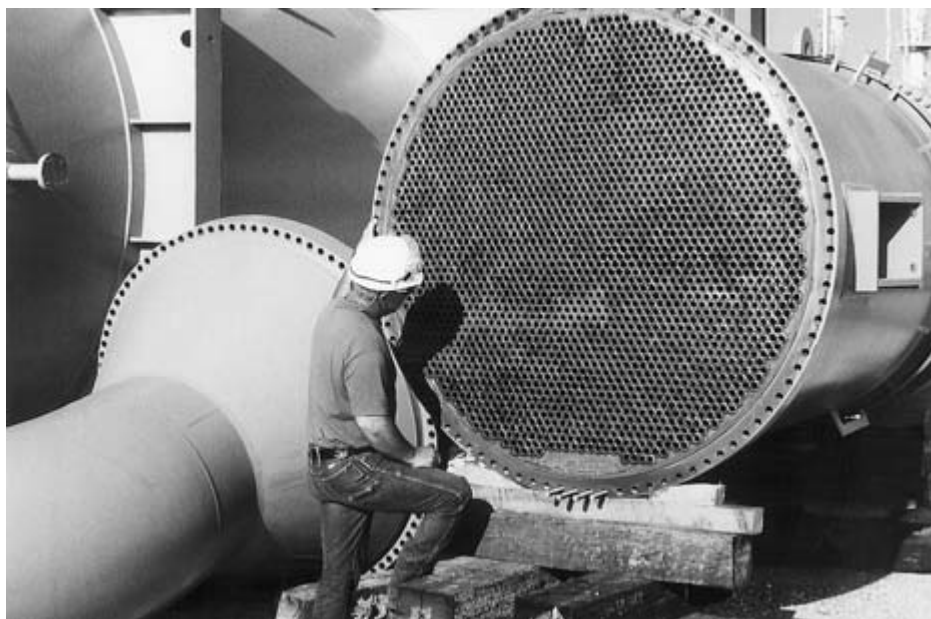
FIGURE 10-6 An inspector inspects new and repaired heat exchangers at the fabrication/repair shop and when they arrive at the plant site.

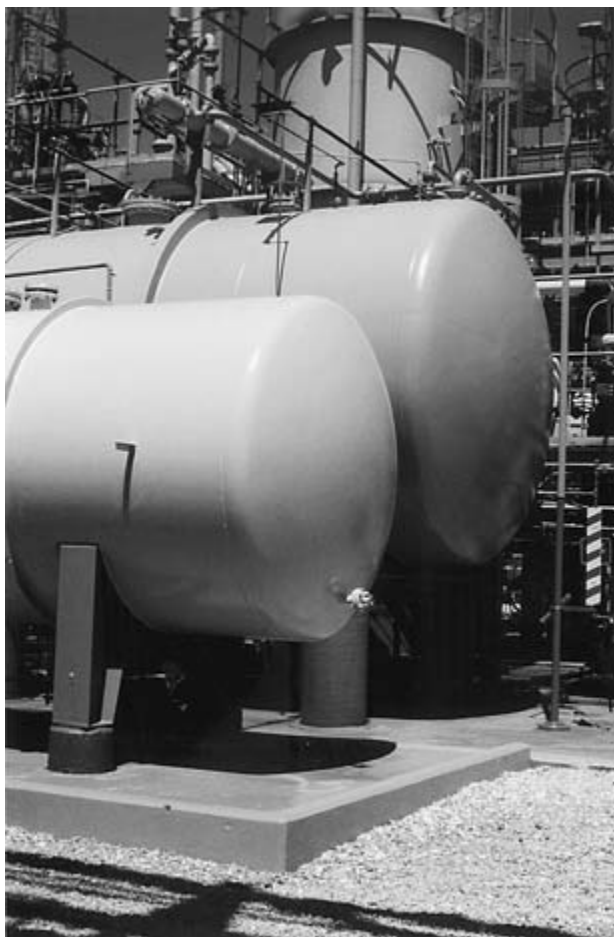
FIGURE 10–7 Well-maintained pressure vessels (over 30 years old) still safely handling hazardous materials.

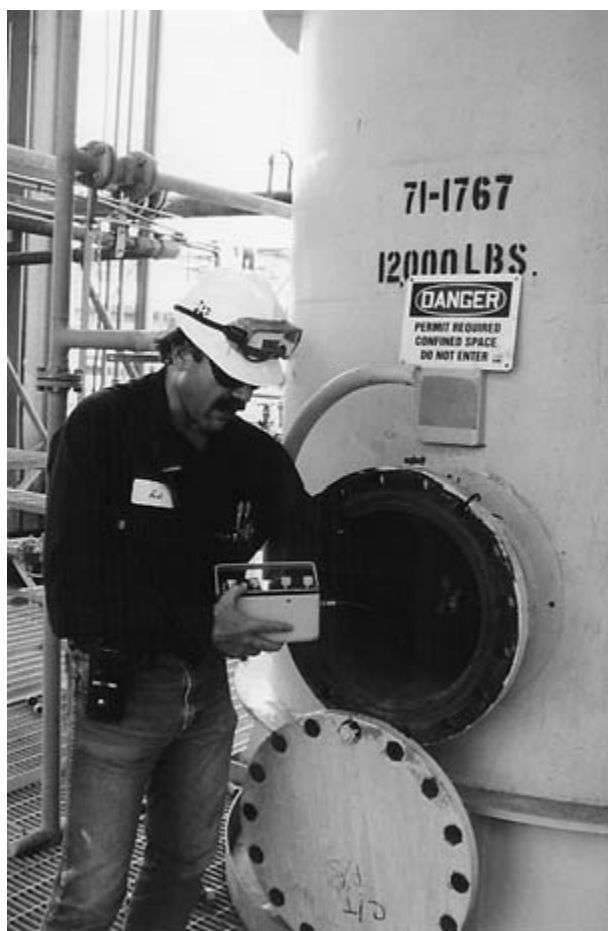
FIGURE 10-8 An operations foreman checks for blinding and samples the vessel's atmosphere before tank entry.

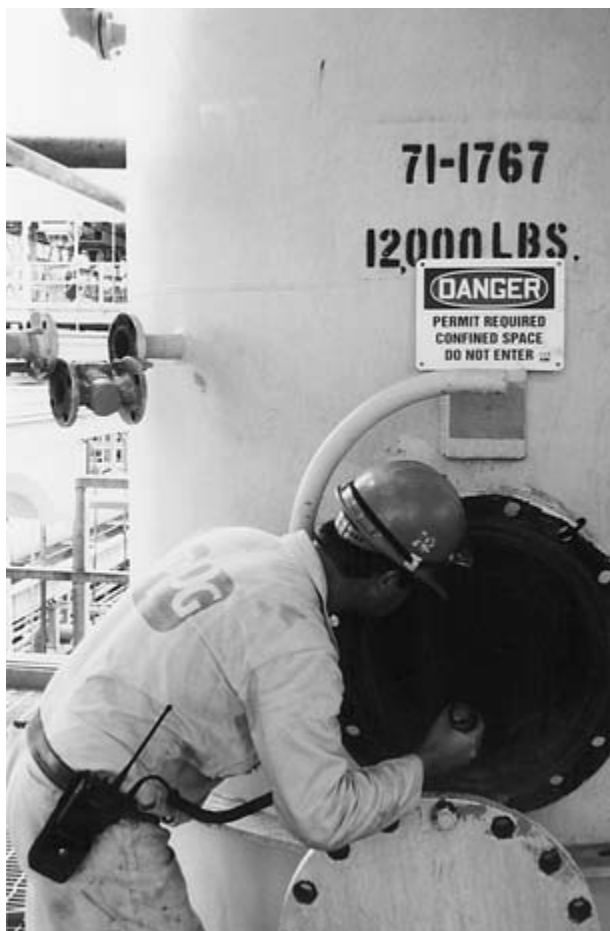
FIGURE 10-9 A pressure vessel inspector making an initial assessment of the vessel and determines any special inspection needs, such as ladders, scaffolding, or extra lighting.

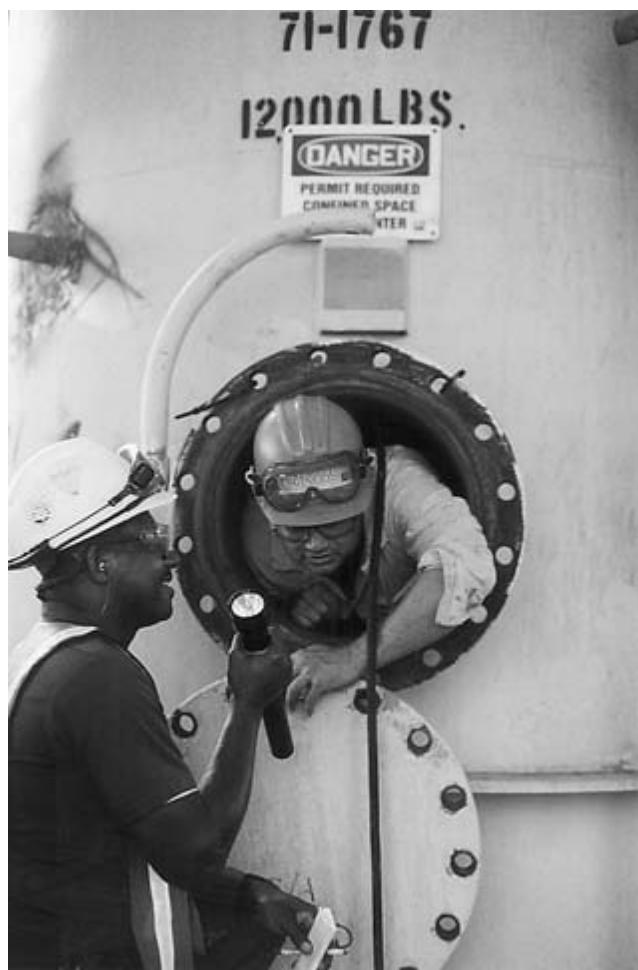
FIGURE 10-10 A pressure vessel inspector enters the confined space after the vessel is blinded, tested, and cleared, but still relies on a manway watch.

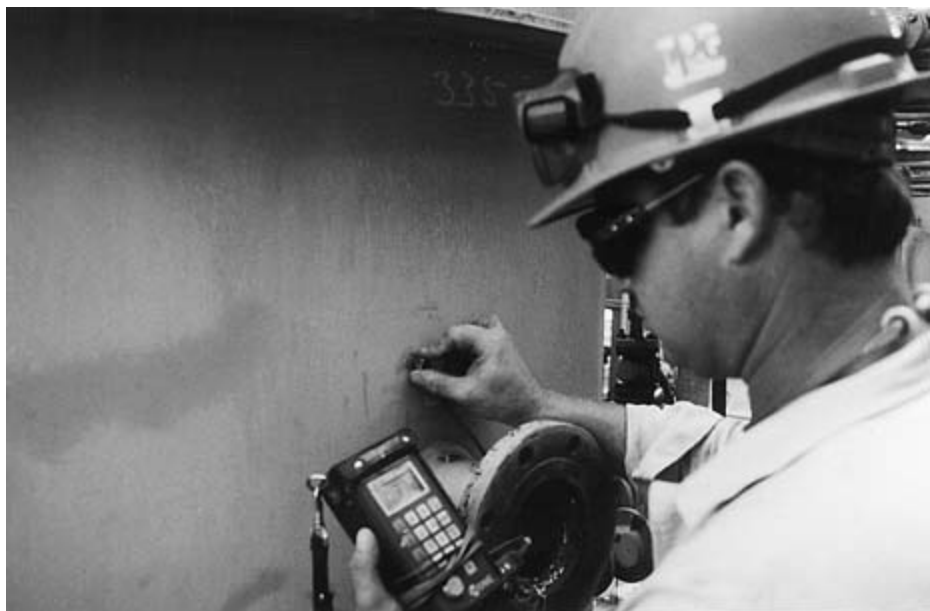
FIGURE 10–11 An inspector verifying wall thickness on a vessel near a nozzle that had experienced metal loss.

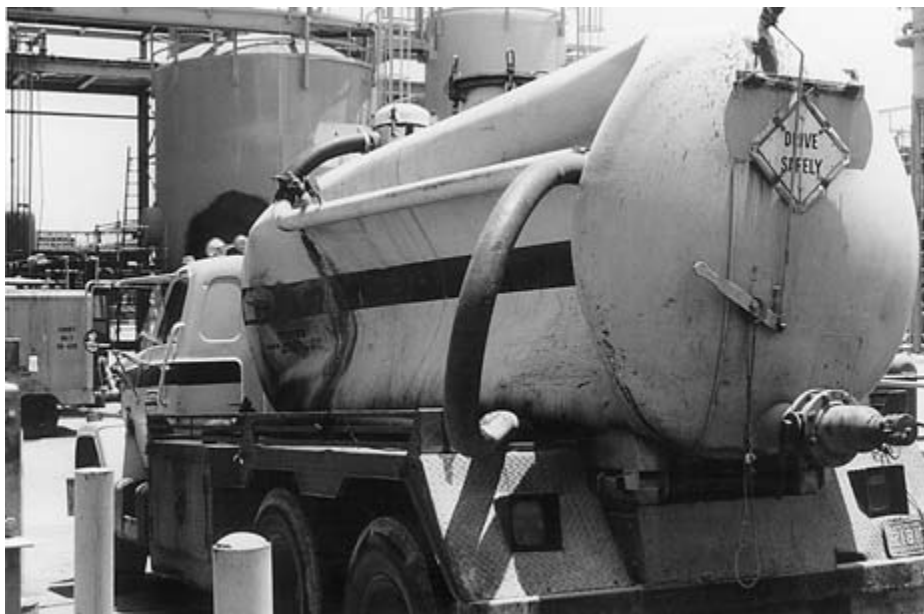
FIGURE 10–12 A collapsed service company vacuum truck signals an inadequate mechanical integrity program.

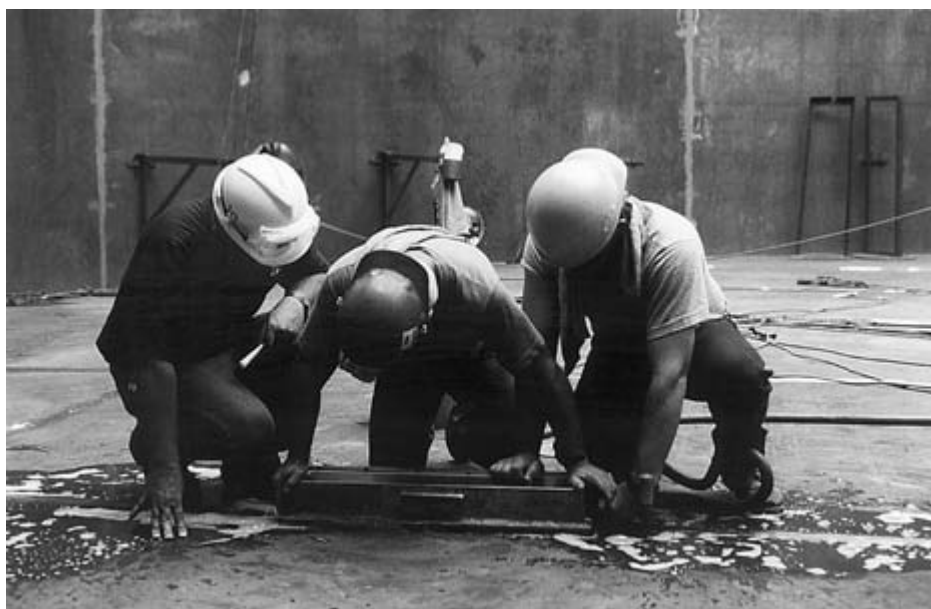
FIGURE 10-13 Inspectors using a vacuum box and soapy water to check for leaks in welds on the floor of low-pressure tanks.

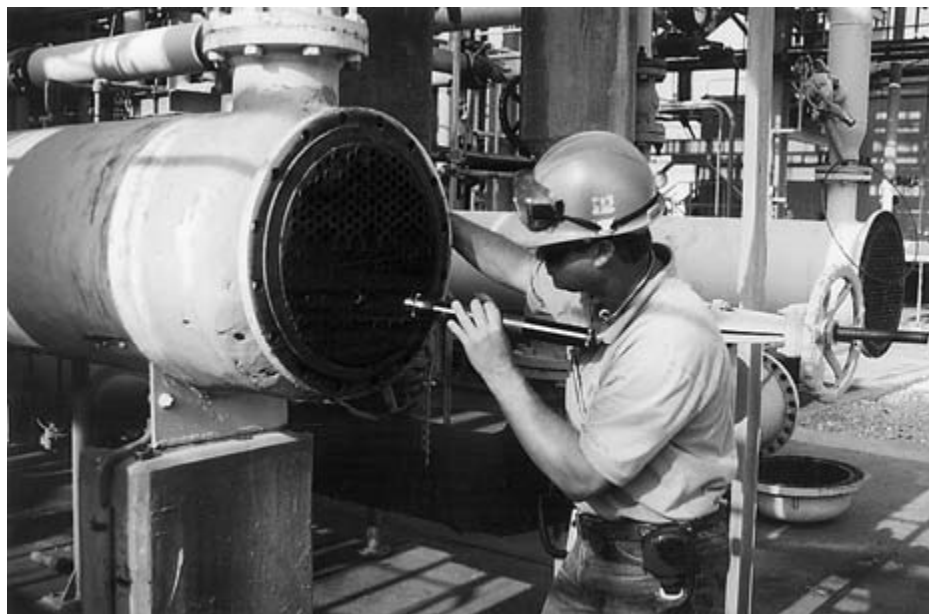
FIGURE 10-14 An inspector examines the condition of the tubes on a condenser. Water-side corrosion can occur if water treatment is insufficient.

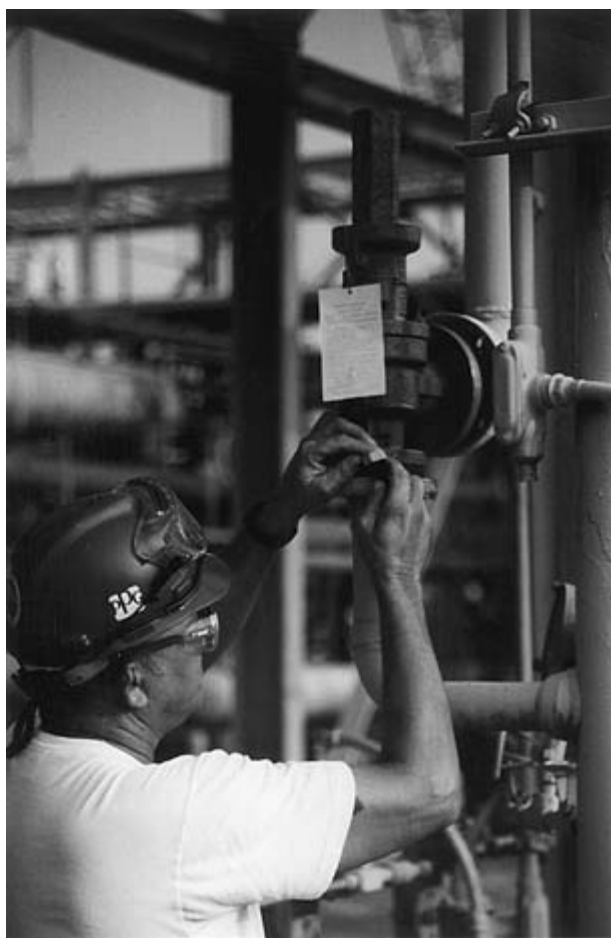
FIGURE 10-17 A mechanic is removing an SRV from a unit. The mechanic records the condition of the inlet and outlet piping components on the tag before the valve is sent for testing.

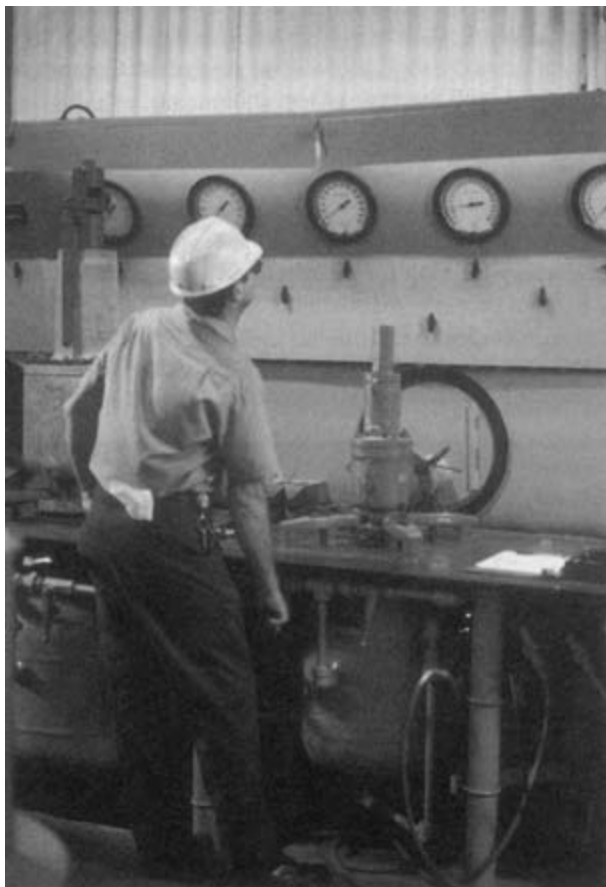
FIGURE 10–18 A well-trained mechanic testing a safety relief valve just as it is received from the unit.

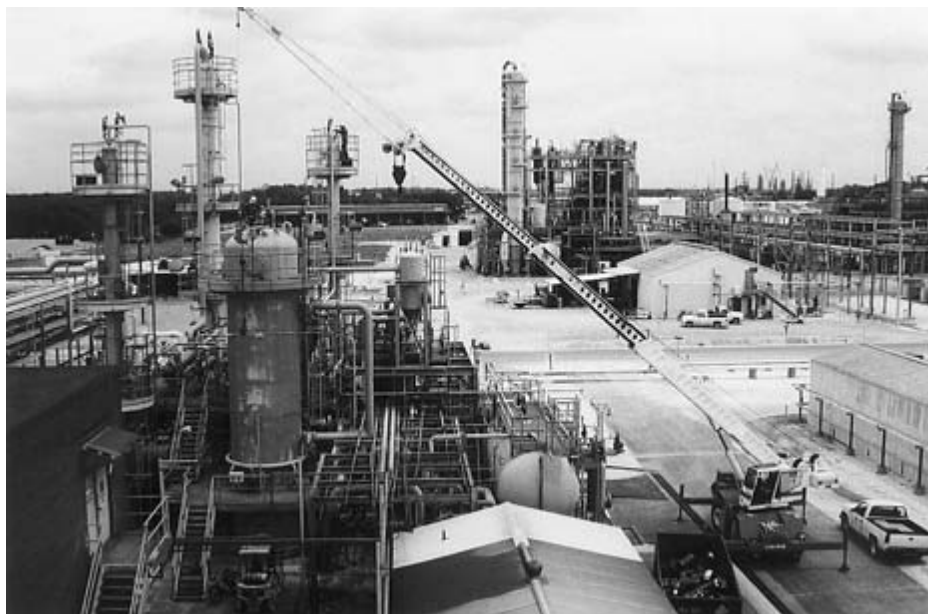
FIGURE 10-19 A crane is lifting a recently tested and reconditioned safety relief valve to reinstall on a reactor.

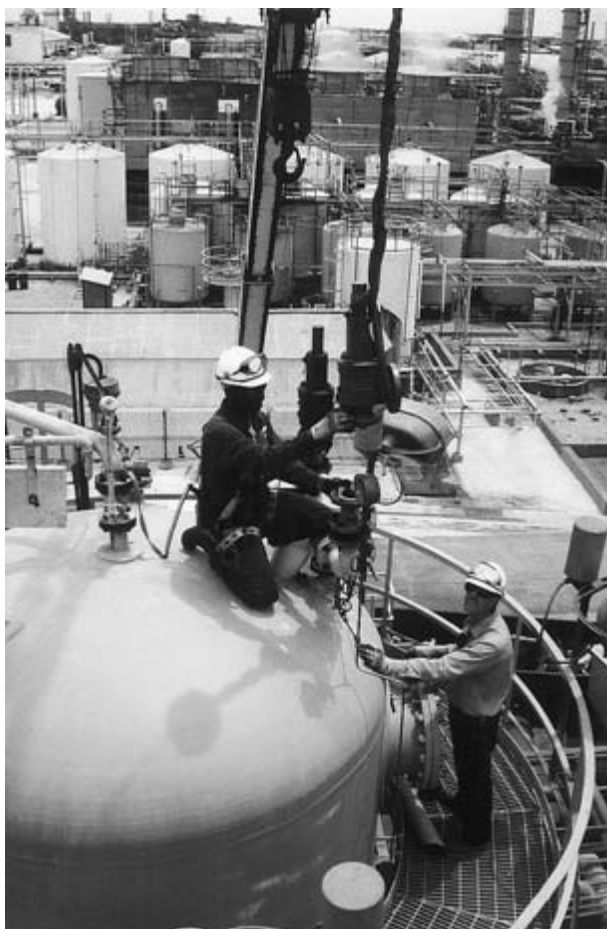
FIGURE 10-20 A mechanic is reinstalling an SRV after it was tested in the shop and raised into position by a crane.

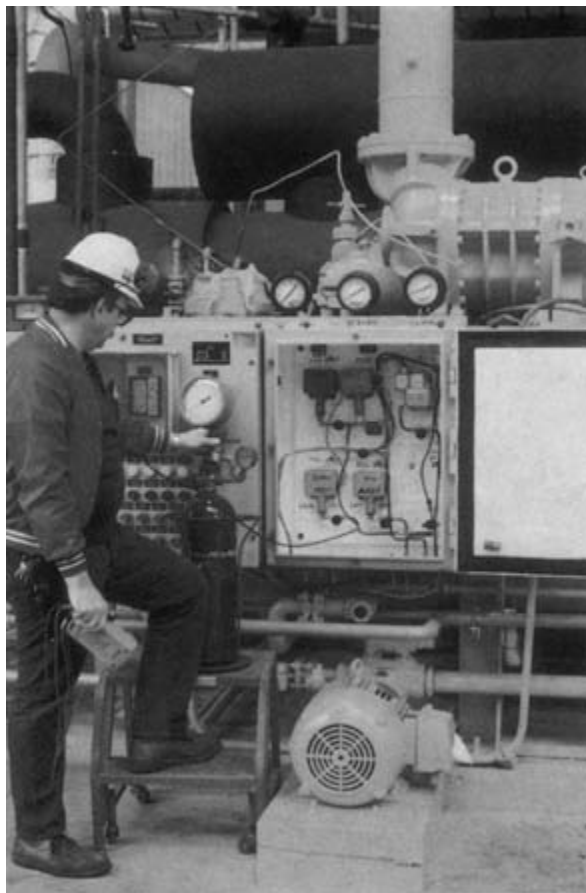
FIGURE 10-22 Prooftesting a high-pressure switch on a refrigeration unit.

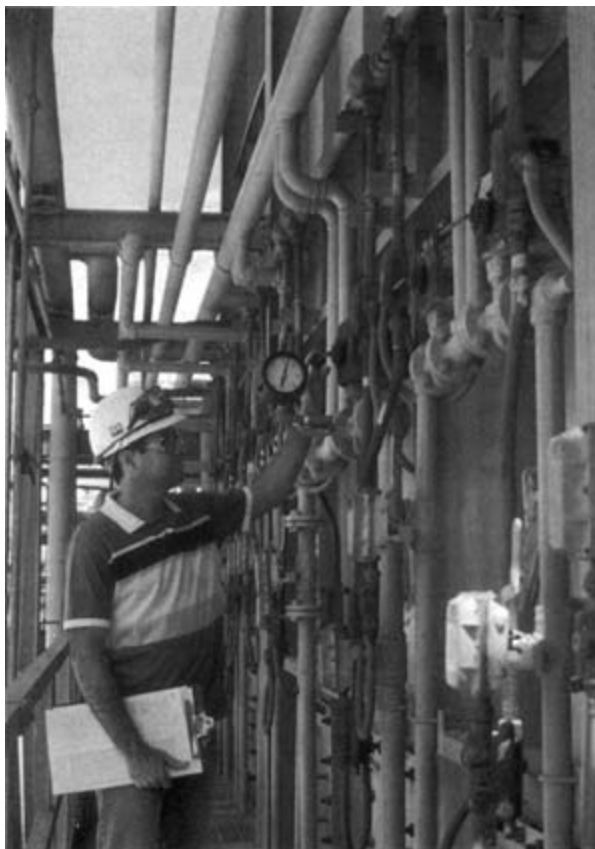
FIGURE 10-23 A chemical process operator relies on a furnace fuel shutdown system.

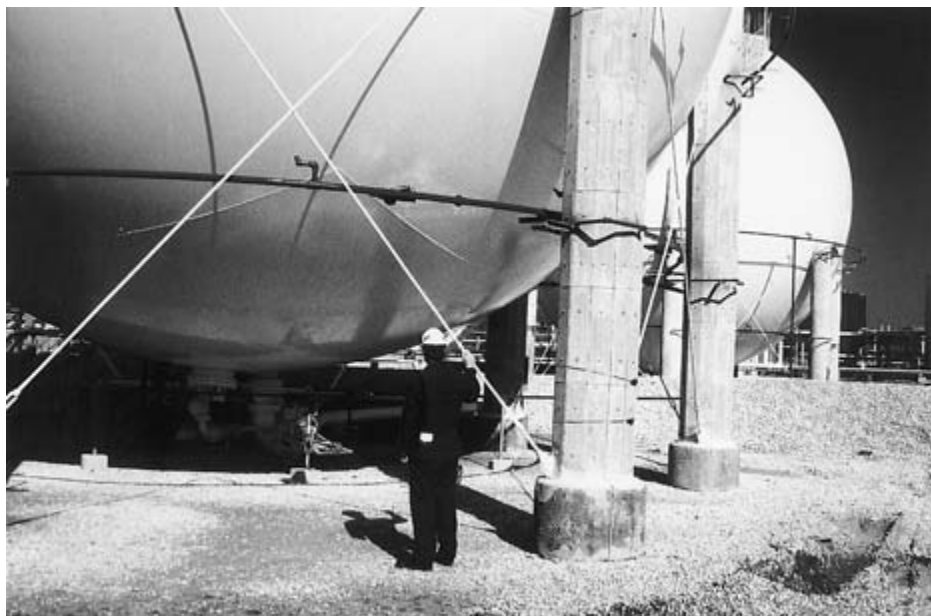
FIGURE 10–24 A chemical process operator witnesses the testing of an “Emergency Isolation Valve” below a sphere of flammable product.

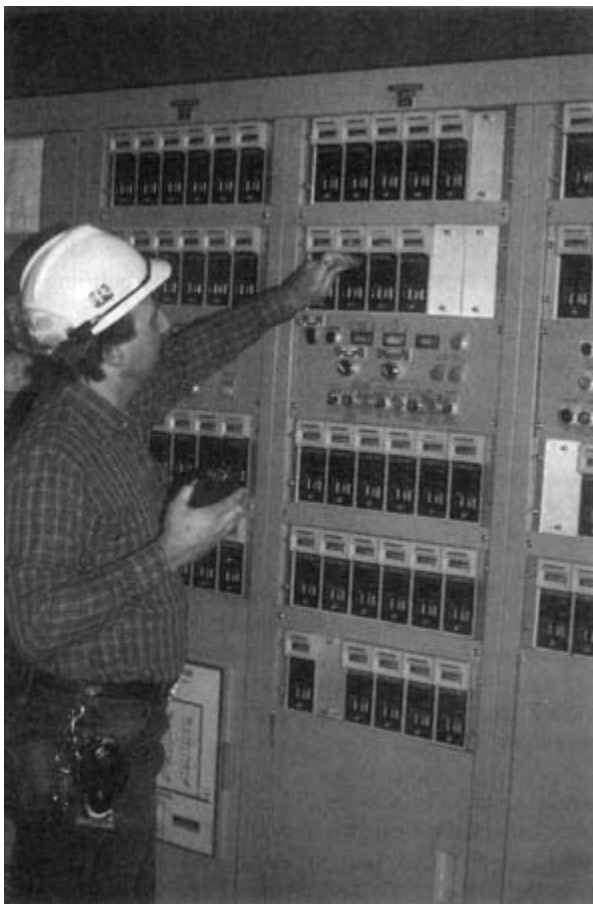
FIGURE 10-25 An instrument mechanic proof-tests a critical instrument panel.

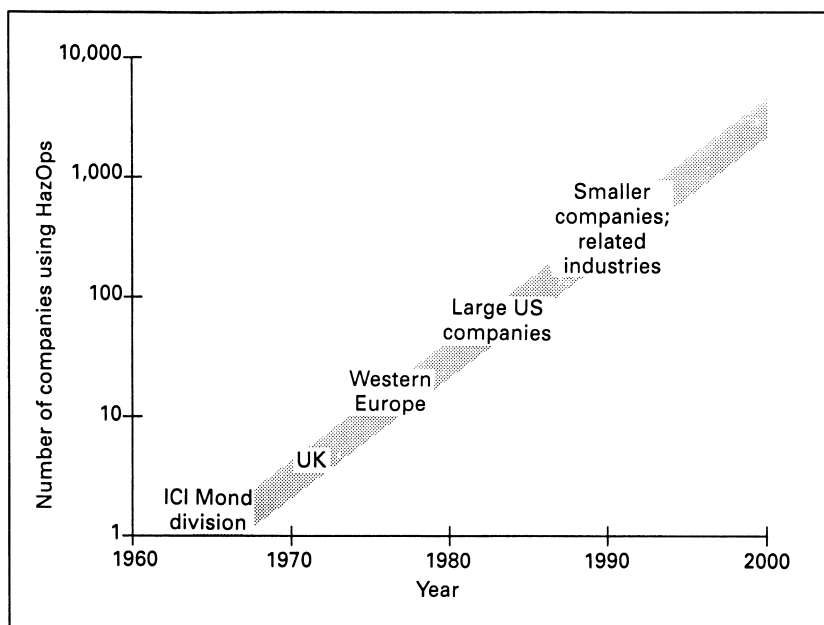
FIGURE 11-1 Estimate of the extent of HAZOP usage. Courtesy of R. W. Johnson, Battelle Memorial Institute.
